# MONITORING OF THE PAR RIVER AND ITS TRIBUTARIES

The monitoring group operates under the citizen science scheme run by the Westcountry Rivers Trust. Comments and opinions in this report are those of the authors only

## OCTOBER 2023.

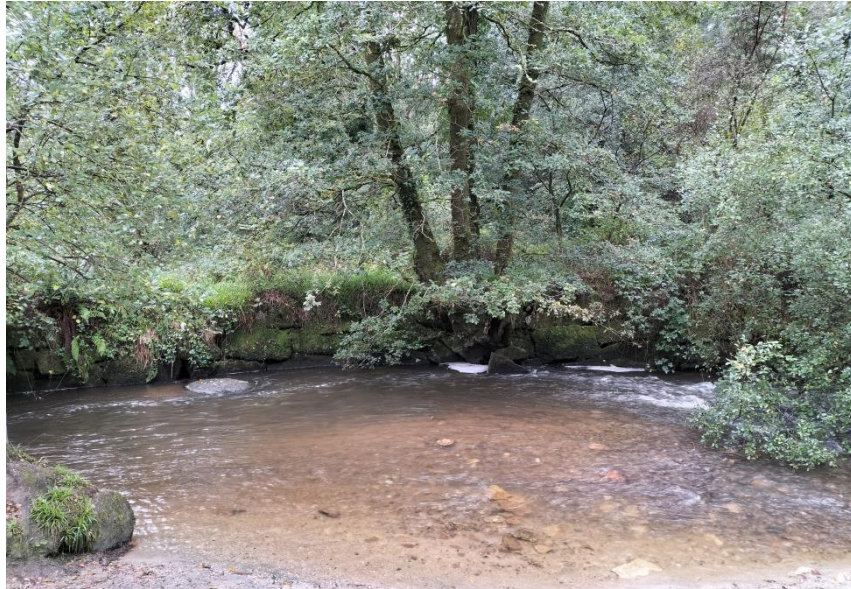
Foam on the outer bend of the river at Lady Rashleigh Mine (SX 06451 56509)

- (a) Phosphate levels remain unacceptably high.
- (b) The Total Dissolved Solids reading at Par Beach was, once again, above the guidance of 300 parts per million.
- (c) Hardly any wildlife was noted.
- (d) The smell at Cam Bridges has been reported by various people as coming from sewage. This evidence is anecdotal but some of the observers do have relevant knowledge. It has probably been under-reported in our monitoring at that spot. The smell is not noticeable closer to the STW at Luxulyan allotments, so it is assumed that the turbulence caused by the weir is releasing the smell. Nonetheless, it is concerning that the presence of sewage can be detected.
- (e) More foam was noted on the 18<sup>th</sup> October than usual. Besides the familiar line of bubbles, assumed to come from the treated effluent outfall at St Austell North STW, larger quantities were seen (see photo on page 1).

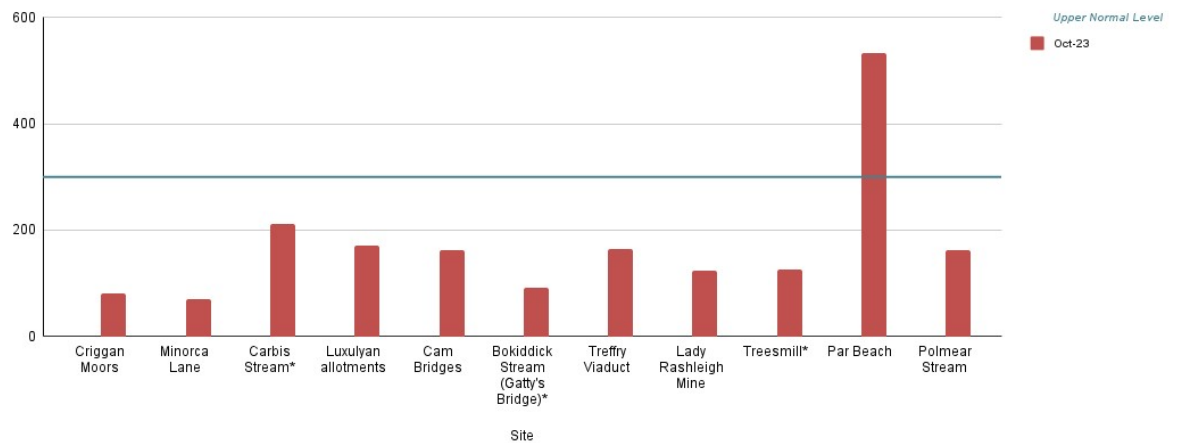
Par River Total Dissolved Solids (PPM) - Filtered

The WRT advice for this river is that it should not exceed 300 ppb.

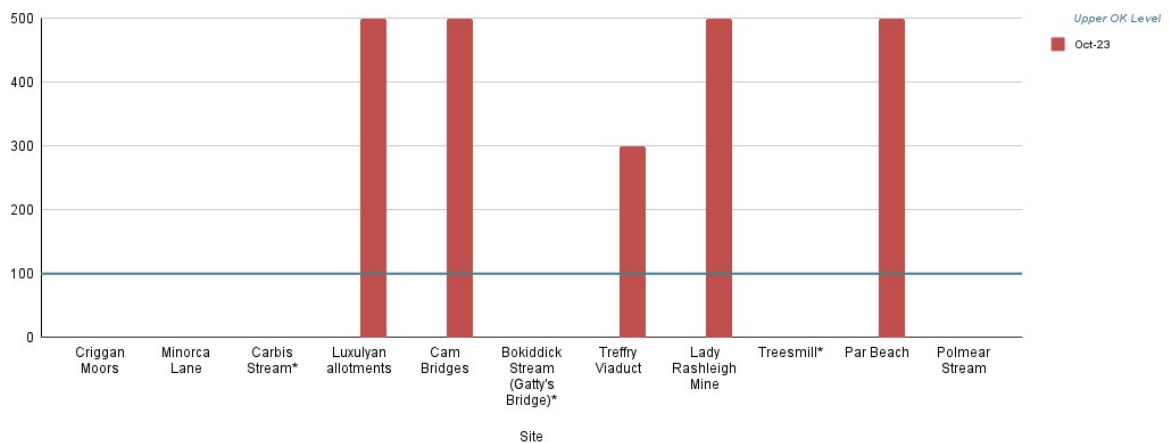
**Par River Phosphates (PPB) - Filtered**

Results in red show phosphate levels that are Too High (WRT advice).

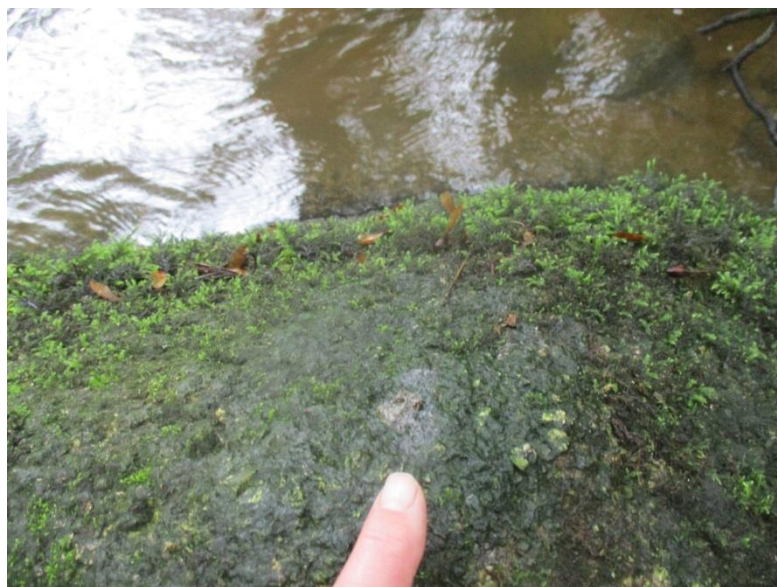
Spraint on boulder at Lady Rashleigh Mine (Lower Par):

Few signs were found last month but spraint was found at two locations at Lady Rashleigh Mine. Other possible locations, such as Ponto Mill, were not visited. The boulder at Luxulyan allotments was not checked because I wasn't wearing waders.

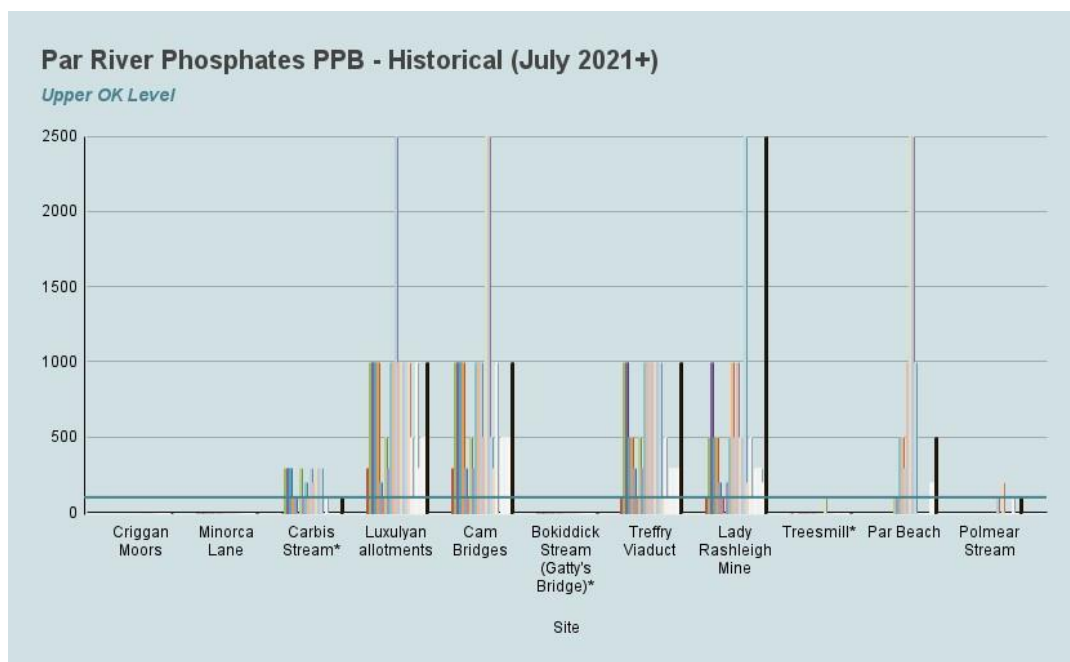
We have consistently detected excessive levels of phosphate in our sampling downstream from the STW at Luxulyan (St Austell North STW). The following graph shows phosphate samples taken from the river since July 2021. Locations with an asterisk are for tributaries so may be ignored. The monitoring point at Luxulyan allotments is approximately 400 metres downstream from the treated effluent outfall at the STW. Our advice is that levels of phosphate exceeding 100 parts per billion are harmful and may lead to eutrophication.

The Environment Agency has been able to confirm that the St Austell North STW is a source of elevated levels of phosphate and ammonia and Defra has identified the Lower Par River in this report: [Urban waste water treatment: identification of sensitive areas notice 2023 schedule - GOV.UK \(www.gov.uk\)](https://www.gov.uk/government/uploads/system/uploads/attachment_data/file/114444/Urban_waste_water_treatment_identification_of_sensitive_areas_notice_2023_schedule.pdf). As the population equivalent of the area has exceeded 10,000, it means that a suitable level of treatment is required. Although there are no firm plans yet, something will be done in the 2025-2030 cycle, which is great news.
