## WESTCOUNTRY RIVERS TRUST CITIZEN SCIENCE MONITORING OF THE PAR RIVER AND ITS TRIBUTARIES

# AUGUST 2022

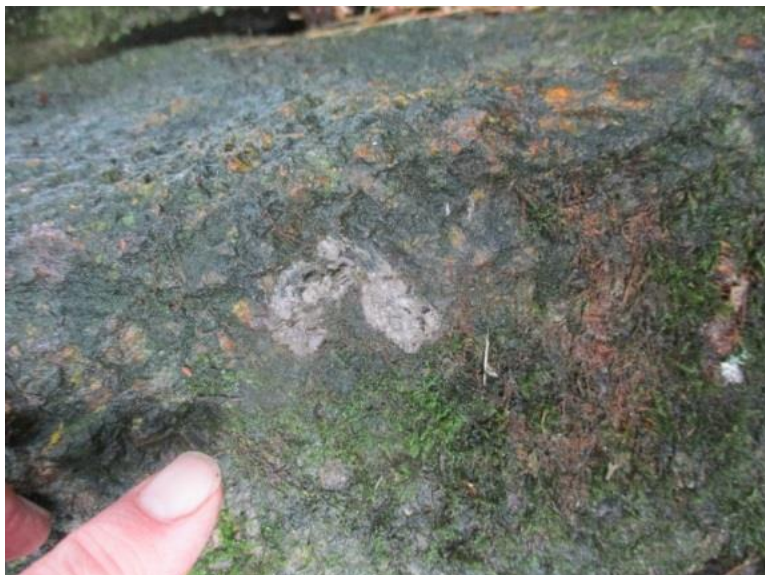
Spraint on boulder near Luxulyan allotments (SX 04747 58056):

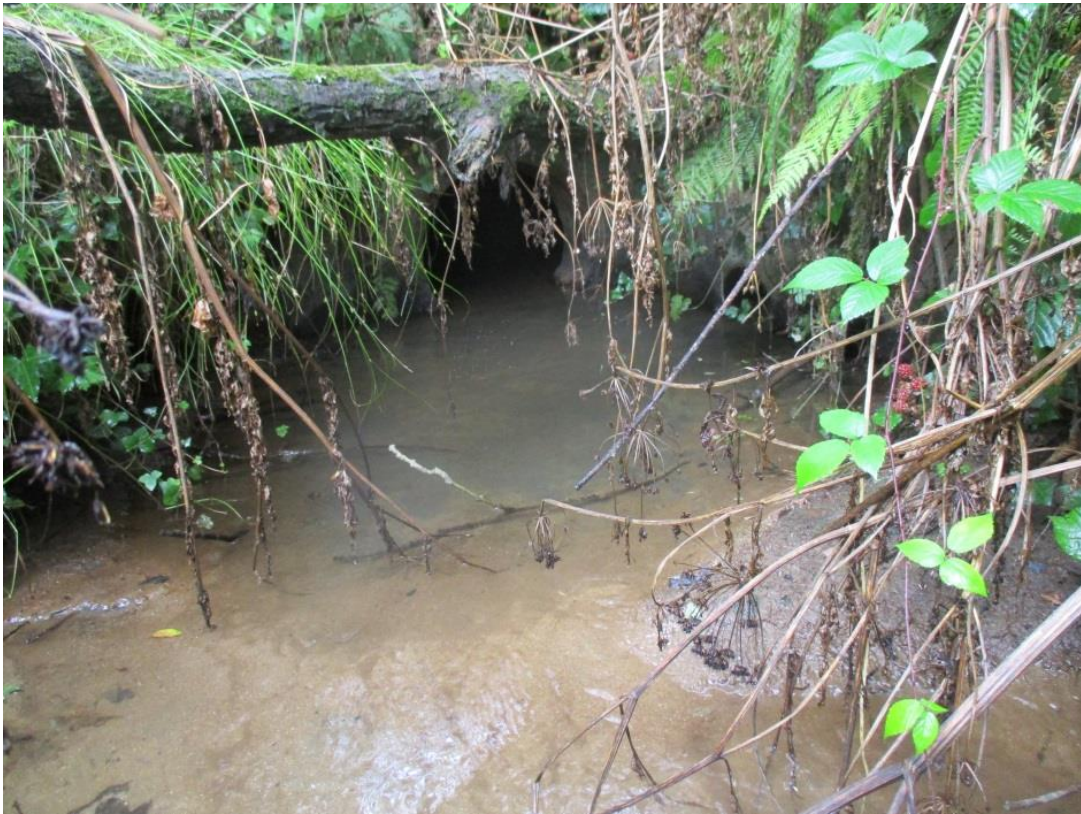
St Austell North sewer storm overflow, 21<sup>st</sup> August 2021

(g) The St Austell North STW sewer storm overflow (Permit number: SWWA 146) was not discharging when we checked on 21<sup>st</sup> August 2022. (See: <https://theriverstrust.org/key-issues/sewage-in-rivers> ).

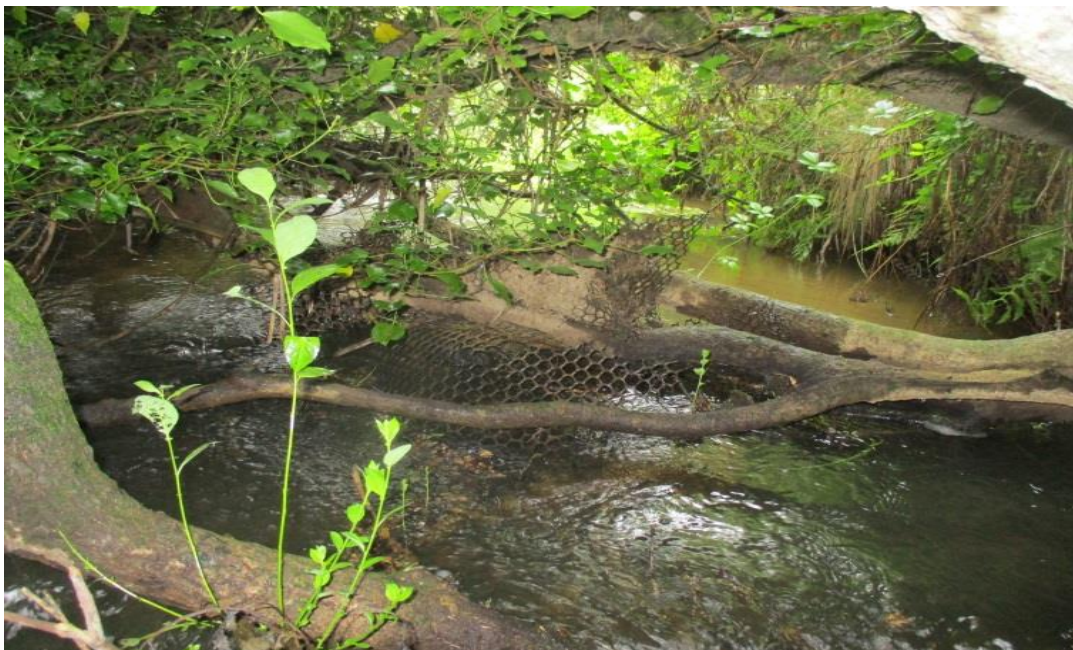
(e) Last month this observation was made: *One of the problems of the Par River is that its course has been heavily modified, i.e. straightened, to the detriment of its biodiversity and also accelerating the speed of flow, particularly after heavy rainfall. Possibly some of this alteration took place a long time ago but near St Austell North STW and Bridges it is noticeable that the bed and banks have been encased in a heavy duty mesh. In places this has broken, possibly as a result of bank erosion, causing a build-up of vegetation and other material (and a hazard for anyone wading in the river).*

This photograph shows the damaged mesh.

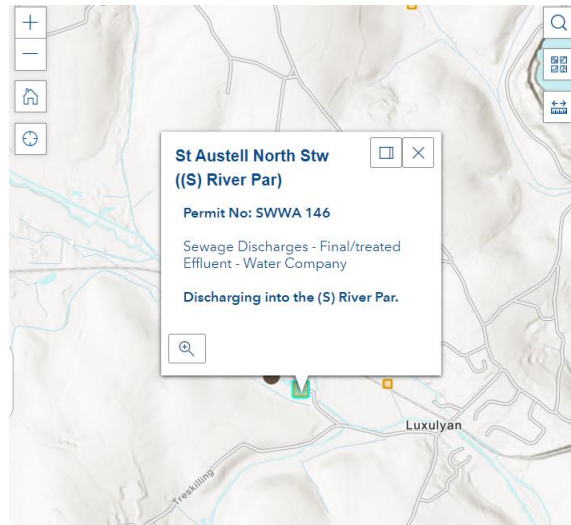
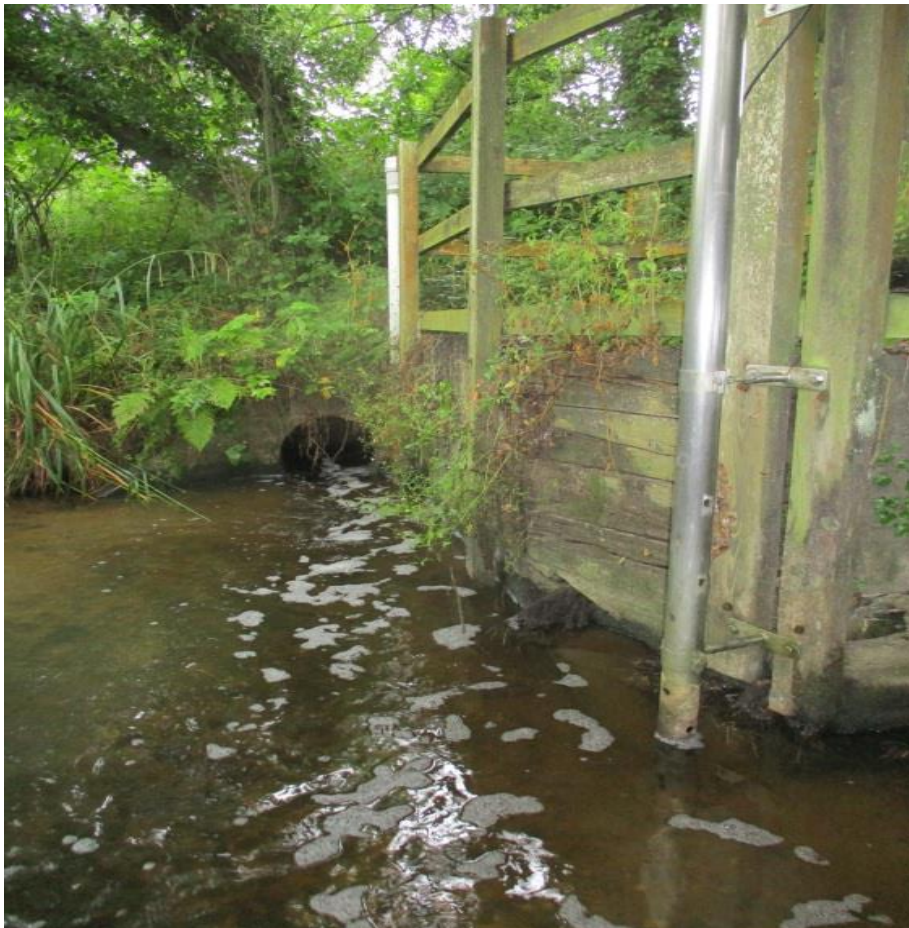
(a) While it was pleasing that the St Austell North STW sewer storm overflow was inactive at the time of monitoring, it should be noted that the treated effluent was, as usual, discharging into the river.

This is permitted and it is not being suggested that the terms of the permit are being breached. The only evidence of this outfall is a slight smell and a trail of bubbles. Additionally, there are fish immediately downstream. However, it would be useful to know the chemical composition of this discharge and whether or not there is reason to change the details of the permit.
