WESTCOUNTRY RIVERS TRUST CITIZEN SCIENCE

MONITORING OF THE PAR RIVER AND ITS TRIBUTARIES

JANUARY 2022

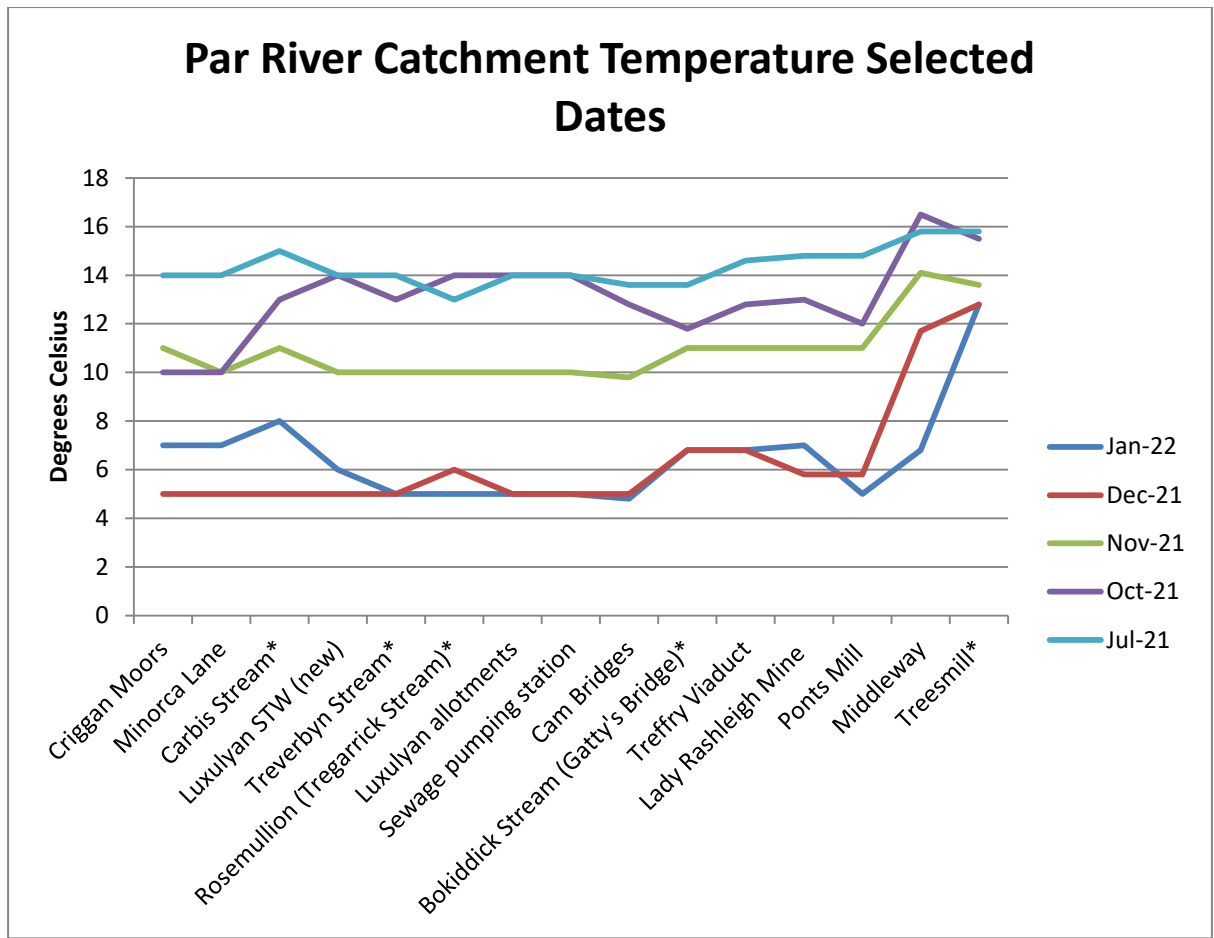
The Tywardreath Marsh Stream at Treesmill has had the highest temperature in 3 of the 5 months selected in the above graph. Middleway has had the highest temperature in the other months, including January 2022. This may be worth watching.

4. The relatively high temperature at Middleway on the Par Canal is noticeable. This may be the result of the level and flow of the stream but it needs to be monitored.

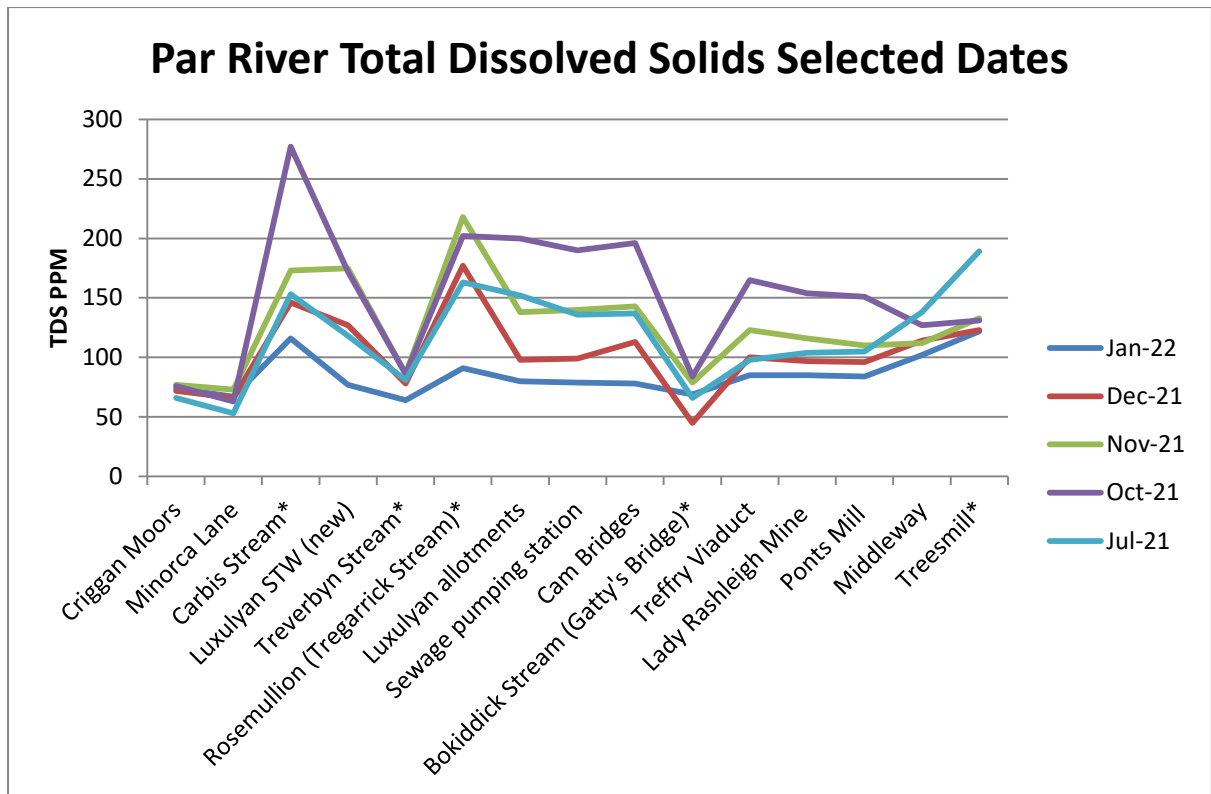
This month Middleway recorded the highest TDS, followed by the Carbis Stream and Treesmill. The Carbis Stream and the Tregarrick Stream at Rosemullion often show relatively high TDS scores. In the former case this is believed to be the result of china clay and in the latter it is believed to be silt that has accumulated as a result of slurry being sprayed on adjacent fields. It isn't known why Middleway and Treesmill should have had such a relatively high score in January 2022.

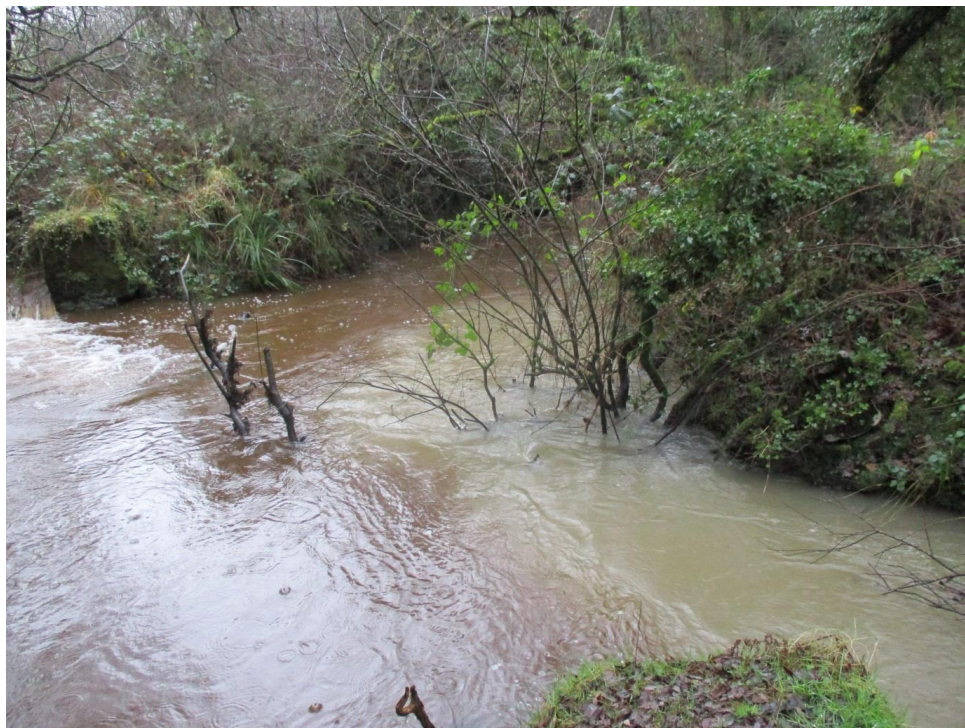
China clay-laden water from Carbis Stream (right) meets the main Par River

2. Turbidity was high in various places, probably reflecting the conditions on 8th January when the river was high and flowing very fast.
3. The presence of what appears to be china clay in the Carbis Stream justifies investigation. It seems that Imerys has permits to discharge into other local rivers and this may be the case here.

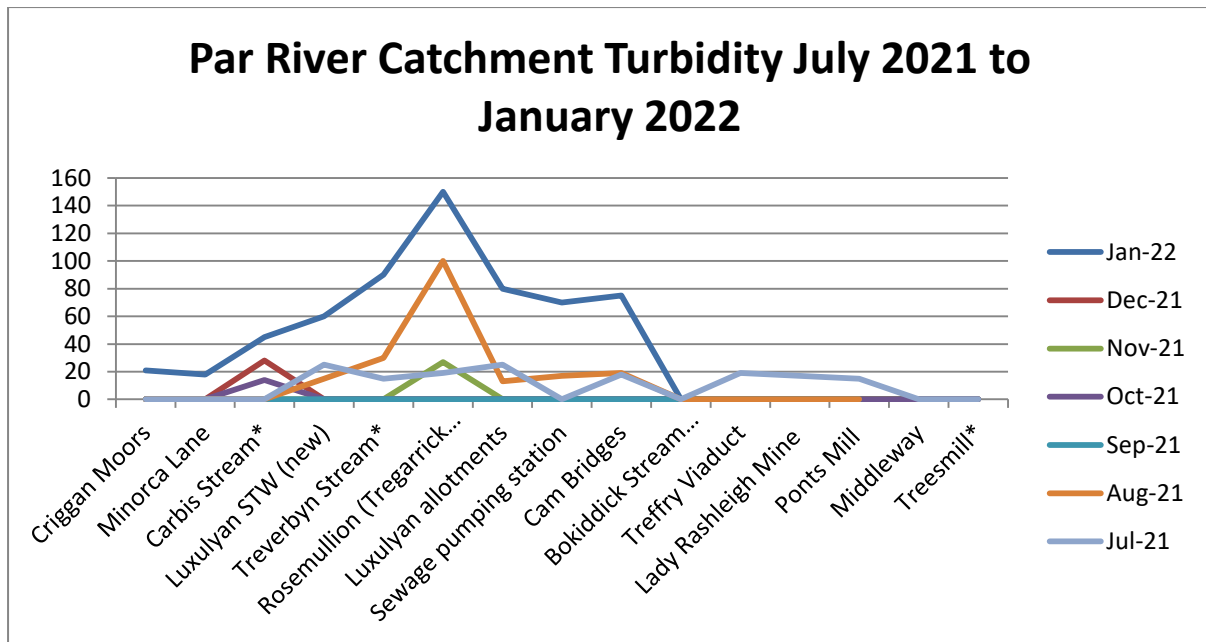
The following graph shows that the Tregarrick Stream (named because of its source at Tregarrick Farm) at Rosemullion often shows the highest levels of turbidity.

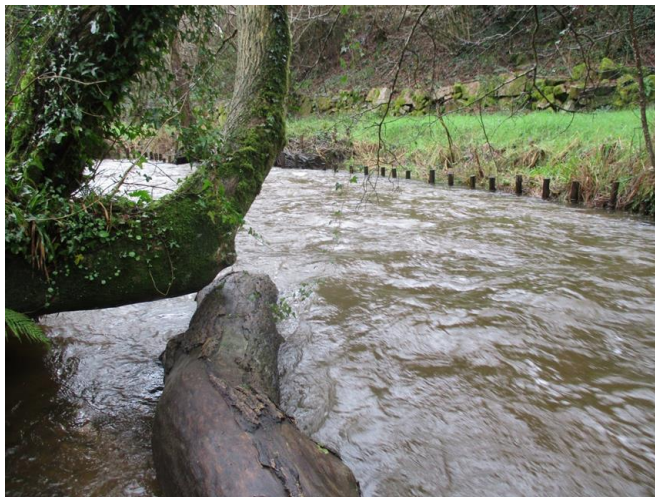
1. Downstream of Pontois Mill sluice looking downstream. Spraint found on this log.

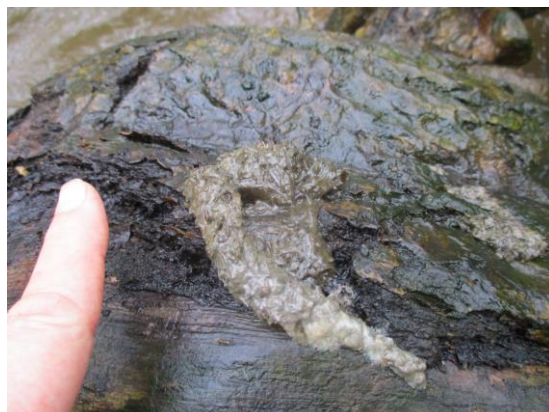
2. Spraint on log.
