WESTCOUNTRY RIVERS TRUST CITIZEN SCIENCE

MONITORING OF THE PAR RIVER AND ITS TRIBUTARIES

JANUARY 2023

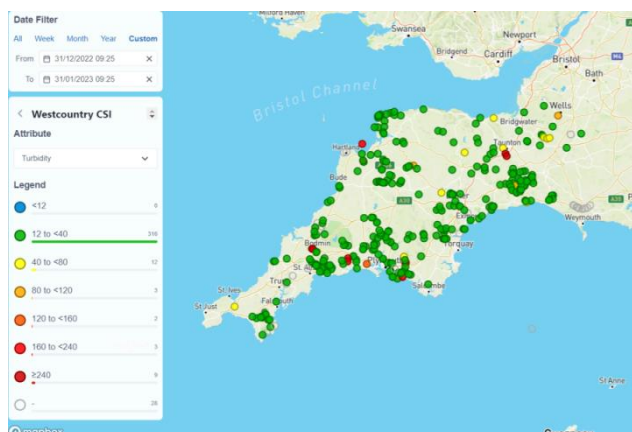
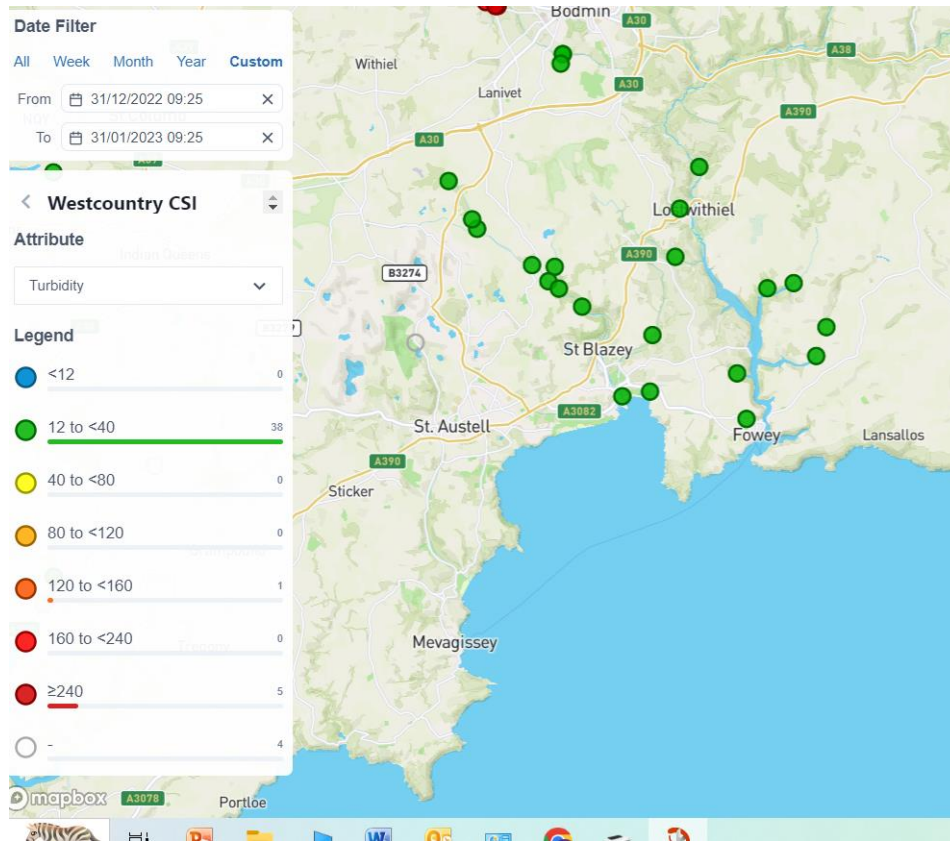
N.B. Cartographer has not shown the results correctly. As the table below shows, only 3 of our locations had Turbidity scores which merit green dots, the majority should be blue.

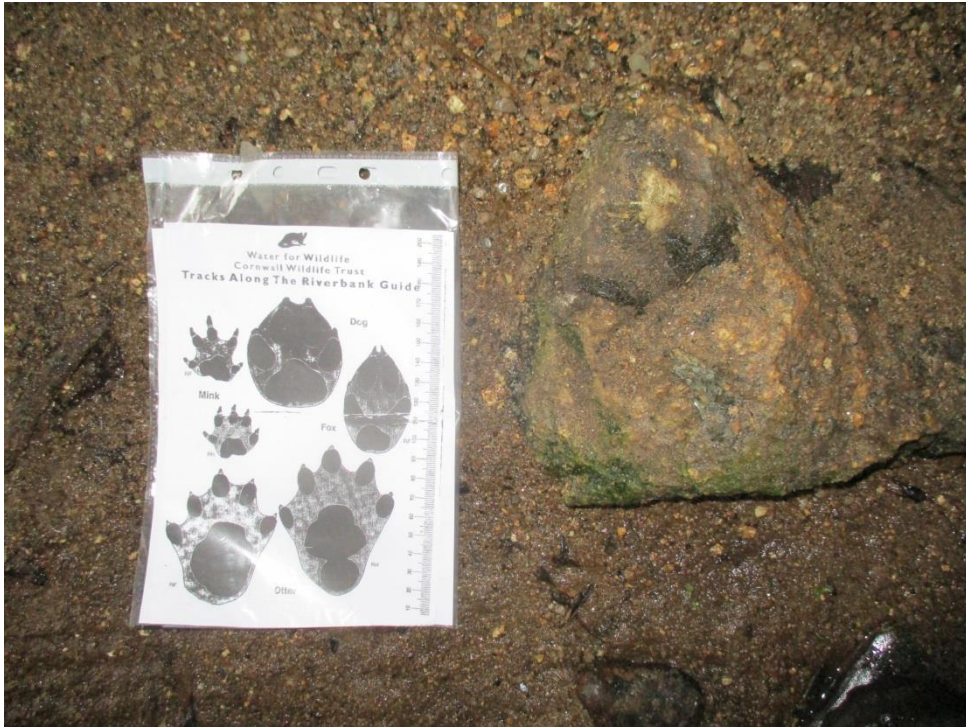
(a) Spraint: 1 old, 2 recent, all containing bones and scales on stone underneath canal bridge at Ponto Mill (SX 07312 56164).

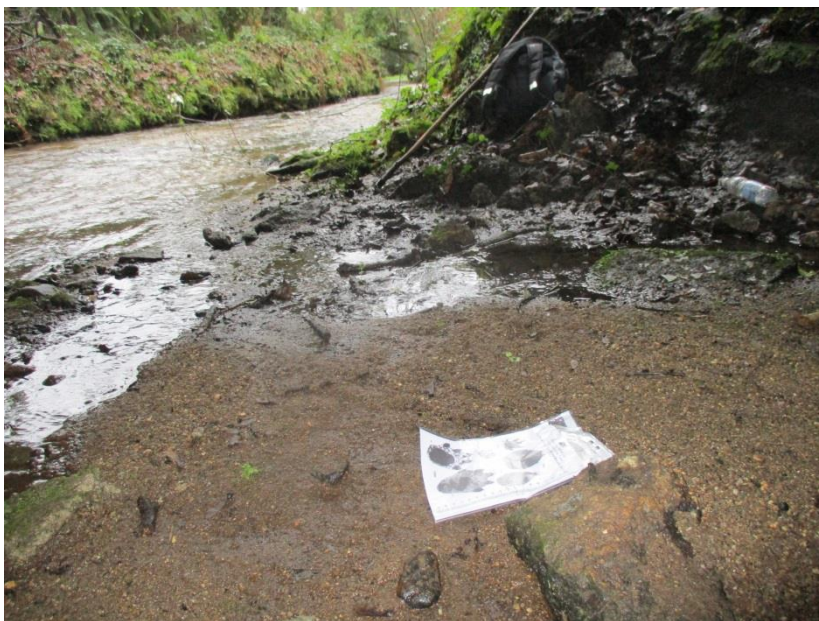
(b) Looking downstream from sprainting spot under the canal bridge at Ponto Mill. Scratch marks could be seen in the sand but it was not possible to discern clear paw prints.

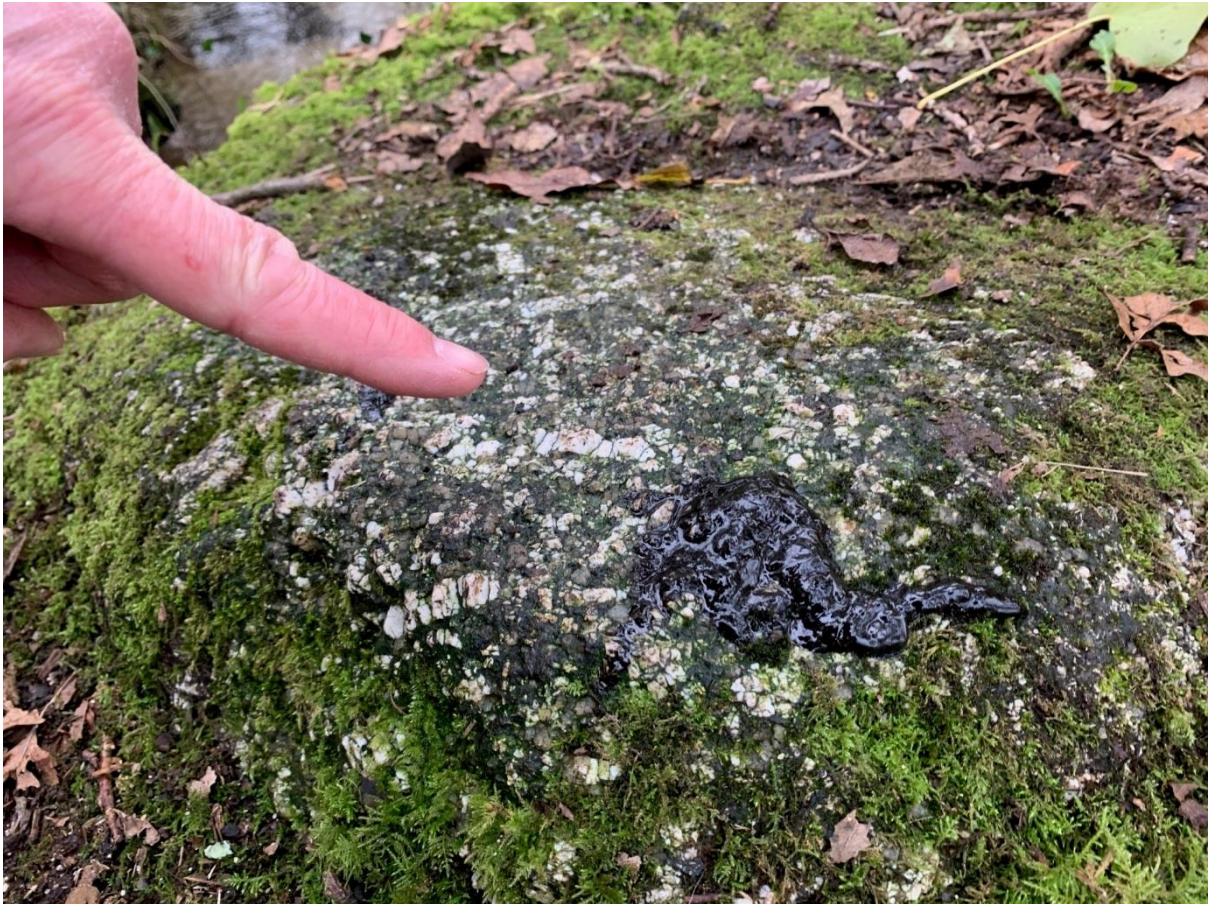
(c) Fresh spraint on bridge over Tredinnick Stream near Trenince Farm (SX 05026 59031).

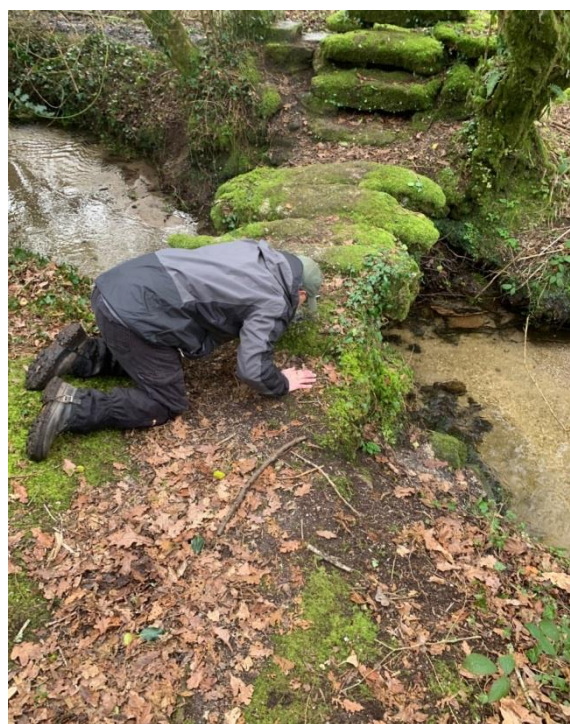
(d) Location of sprainting spot. Note the clarity of the water.

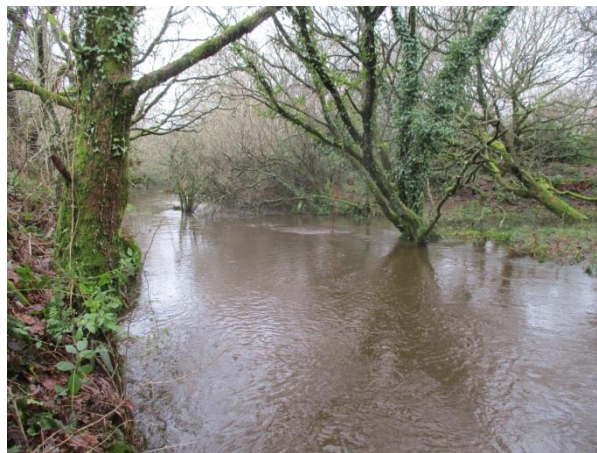
Flooding. This was most serious in the Minorca Lane area where the public footpath was impassable (see photo below) and much of the surrounding land was underwater. Given concerns expressed in the December 2022 about the groundwater infiltration sewerage systems in the main Minorca Lane settlement, and the possible impacts on the health of residents and of the river, and the likelihood of more frequent flooding, this may be something that deserves attention.
