## WESTCOUNTRY RIVERS TRUST CITIZEN SCIENCE

# MONITORING OF THE PAR RIVER AND ITS TRIBUTARIES

## JUNE 2022

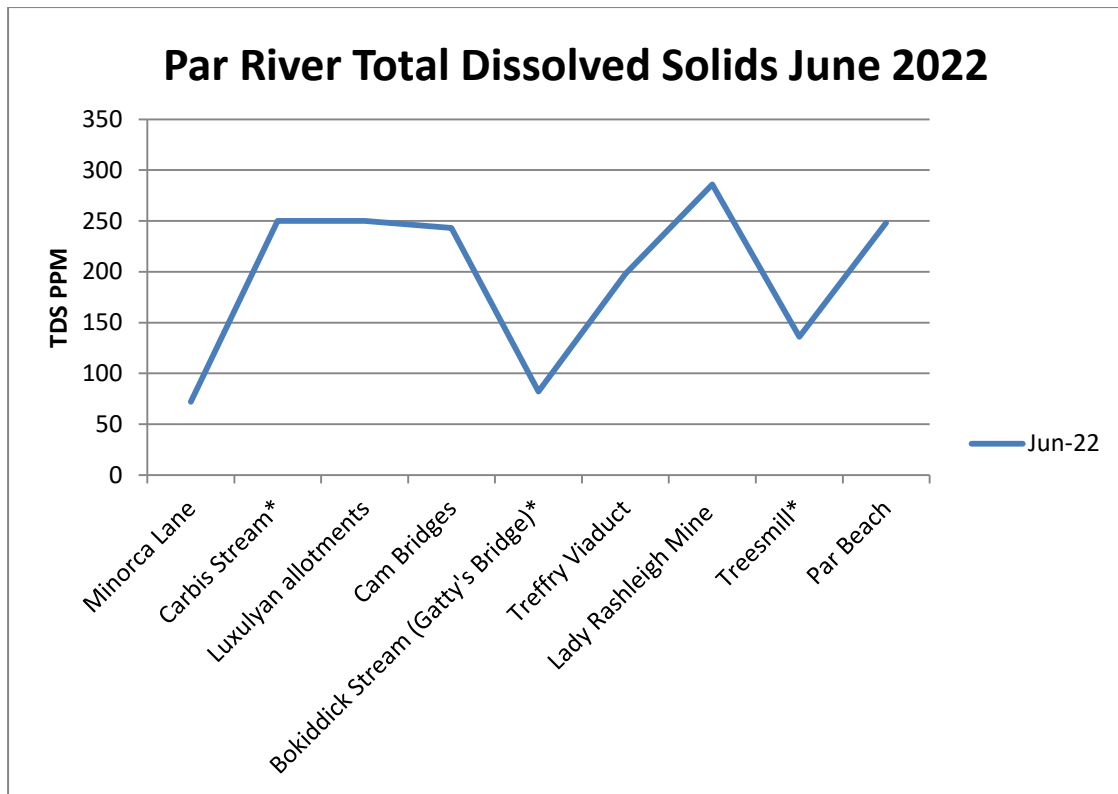
(a) Total Dissolved Solids results at the following points exceeded 200 Parts per Million: Carbis Stream; Luxulyan allotments; Cam Bridges; Lady Rashleigh Mine; Par Beach. We don't know if this is significant. It may just reflect low river levels. But if we assume that higher levels of TDS are not good, this is a point of concern.

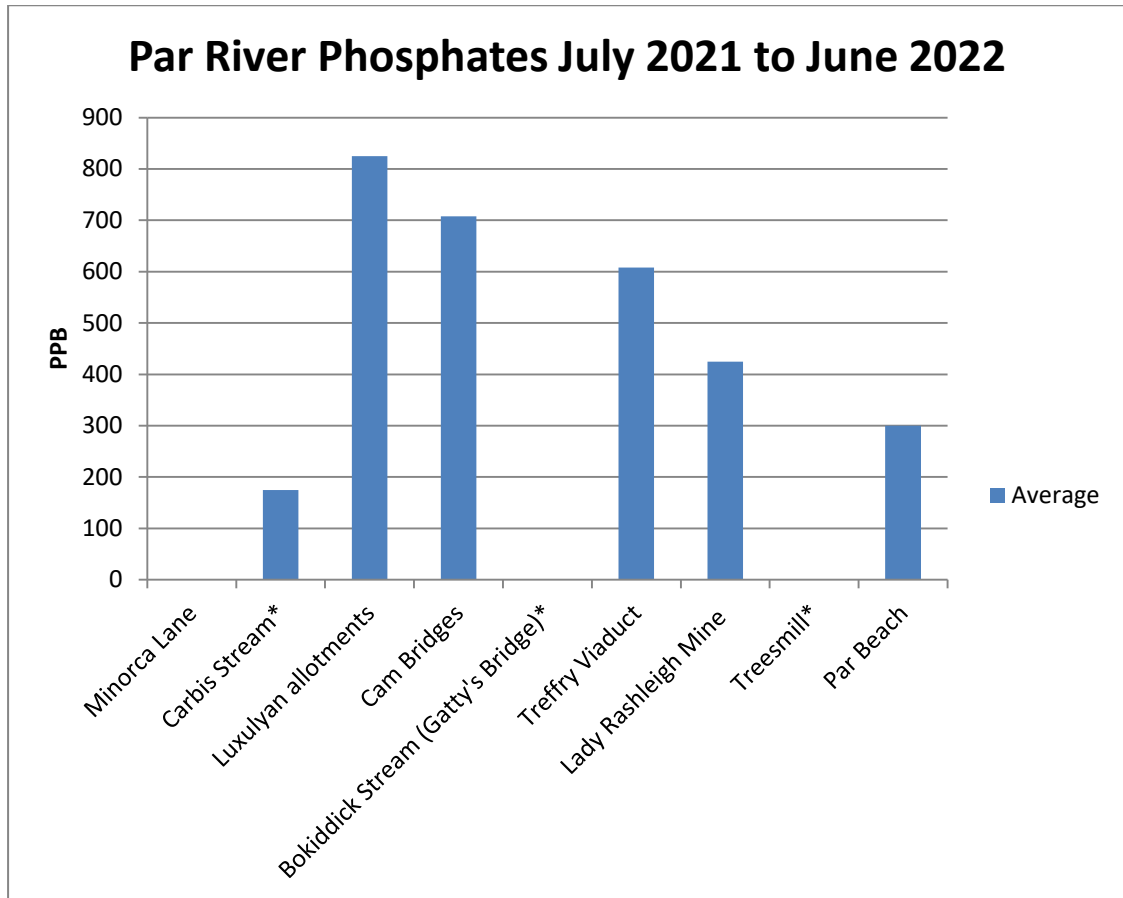
**Par River Phosphate levels**

N.B. Guidance from WRT states that Phosphates Parts Per Billion should not exceed 100.

(b) Phosphates remain alarmingly high. Although low river levels may be relevant, it does not excuse the situation. WRT classifies any reading below 100 Parts per Billion as OK; therefore anything above that is not. A score of 300 PPB on the Carbis Stream was High according to WRT guidelines. This may be connected to china clay pollution, although the water was clear this time. It seems that Imerys has permission to discharge into this stream. However, the really excessive levels of Phosphates were noted first at Luxulyan allotments. Indeed the score of 2500 PPB was the maximum that our testing kit could register. In the past, a score of 2500 at Luxulyan allotments has prompted us to contact the Environment Agency hotline. At the monitoring sites downstream the scores were: 1000, 1000, 500 and 300 PPB – either High or Too High. The graph for average scores since July 2021 on page 17 demonstrates that the Lower Par River (from Luxulyan downstream) has a serious problem with Phosphate pollution. Previous investigations from the Environment Agency lead us to believe that the source is the St Austell North Sewage Treatment Works at Luxulyan. We need an independent enquiry into the source of this pollutant and the impact on the health of the river. If the SWW plant is having a negative impact on the river this ought to be made public and moves undertaken to get a resolution.

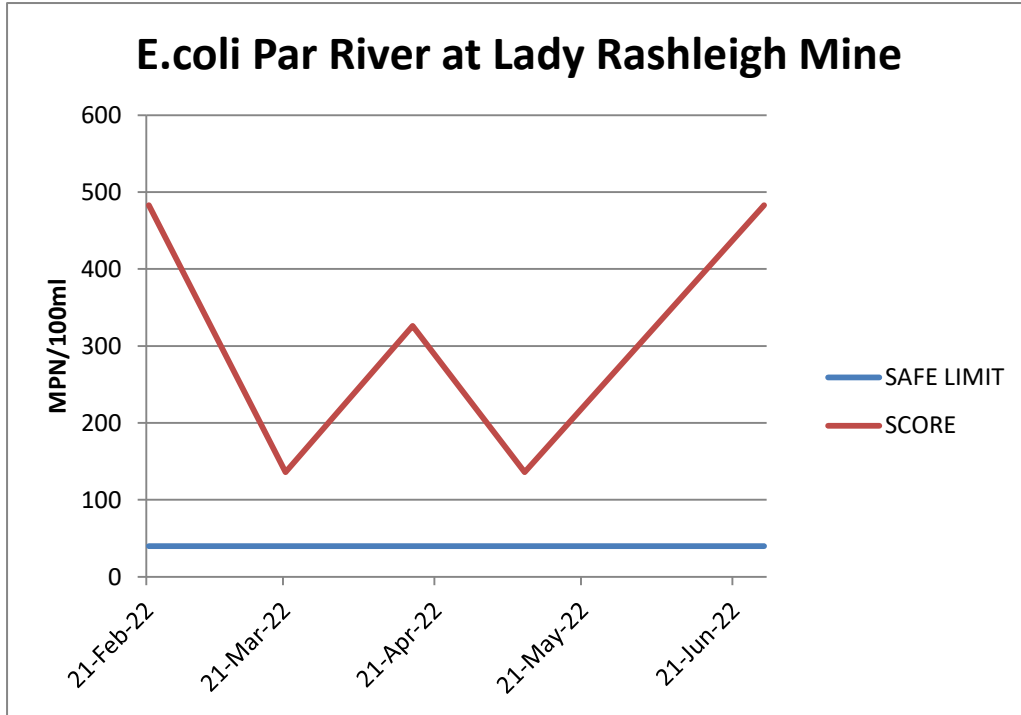
- (i) E.coli was 483 MPN/100 ml, which is considered to be **High Risk/Probably Unsafe**.

The testing kit comes from the USA and the judgements reflect US standards: it is not known what, if any, standards are applied to British rivers. E.coli readings for June would be classified as *Very High Risk/Unsafe*. The Coliform score is judged *Very Unsafe*. That said, we are not aware of any person or animal being adversely affected by the water in the river here or at other locations, so it would be wrong to be alarmist.

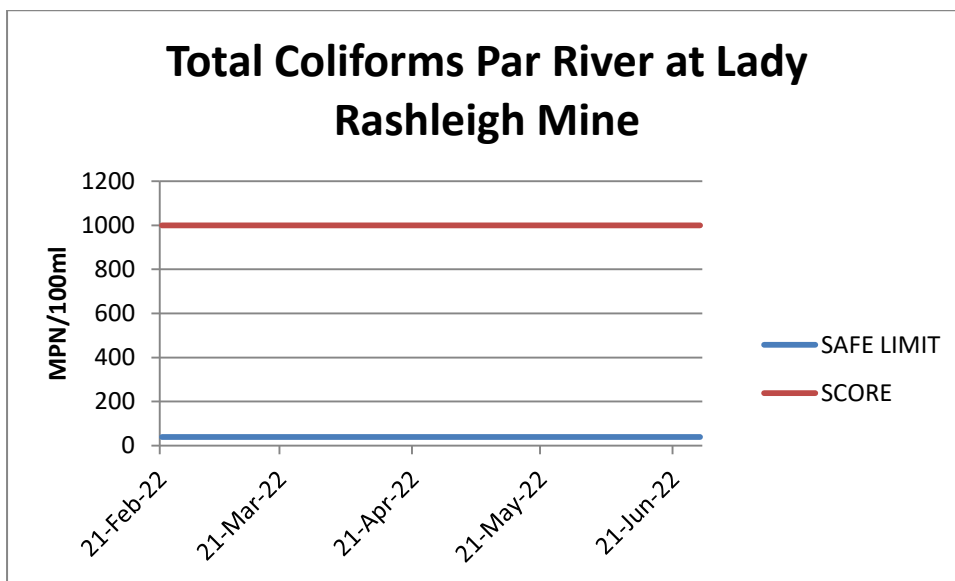
- (ii) **Total Coliforms**  
The reading was >1000/Very Unsafe.
