# MONITORING OF THE PAR RIVER AND ITS TRIBUTARIES

# **SEPTEMBER 2023**

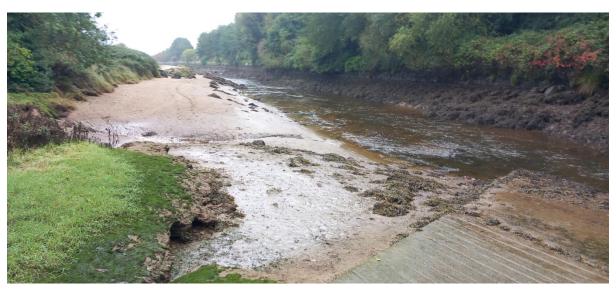
Record TDS score at Par Beach slipway near where the river meets the sea. Photo: Brian Harrisson

- (a) Readings at Par Beach slipway were very concerning: 914 parts per million for Total Dissolved Solids and 500 parts per billion for phosphates. Monitoring took place at low tide. We have been advised that a river like ours should not have Total Dissolved Solids exceeding 300 ppm. Readings at this location are often high, exceeding 300 ppm 5 times since September 2022, yet never as high as this. It is unique in the entire West Country survey area for the last month, although some other coastal locations did record scores in excess of 350 ppm. The survey took place on a later date than the surveys upriver, so comparison with those TDS and phosphate scores can't be made.

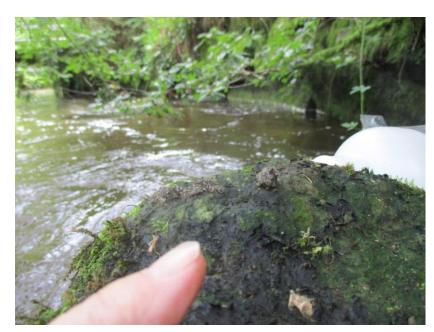
Old otter spraint at Luxulyan allotments, SX 04747 58056

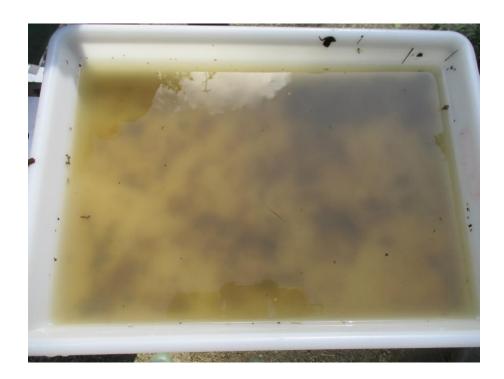
- (b) Phosphate scores from Luxulyan allotments downstream were 'High' (WRT categorisation).
- (c) Flecks of foam are usually seen downstream from St Austell North STW. This is assumed to come from the treated effluent outfall. On 18<sup>th</sup> September more foam than usual was seen. Additionally, after washing off stones during the riverfly sampling (after the kick-sample had been taken) we noticed how dirty the water was, as the photo shows:

This may have been a result of the heavy rain in the previous 24 hours. That said, we have conducted riverfly sampling using the same method after periods of heavy rain but have never noticed such discolouration of the water.

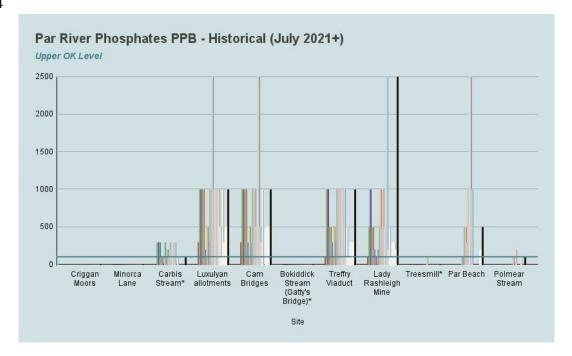
We have consistently detected excessive levels of phosphate in our sampling downstream from the STW at Luxulyan (St Austell North STW). The following graph shows phosphate samples taken from the river since July 2021. Locations with an asterisk are for tributaries so may be ignored. The monitoring point at Luxulyan allotments is approximately 400 metres downstream from the treated effluent outfall at the STW. Our advice is that levels of phosphate exceeding 100 parts per billion are harmful and may lead to eutrophication.

The Environment Agency has been able to confirm that the St Austell North STW is a source of elevated levels of phosphate and ammonia and Defra has identified the Lower Par River in this report: <a href="Urban waste water treatment: identification of sensitive areas notice 2023 schedule - GOV.UK (www.gov.uk)</a>. As the population equivalent of the area has exceeded 10,000, it means that a suitable level of treatment is required. Although there are no firm plans yet, something will be done in the 2025-2030 cycle, which is great news.
