WESTCOUNTRY RIVERS TRUST CITIZEN SCIENCE

MONITORING OF THE PAR RIVER AND ITS TRIBUTARIES

FEBRUARY 2023

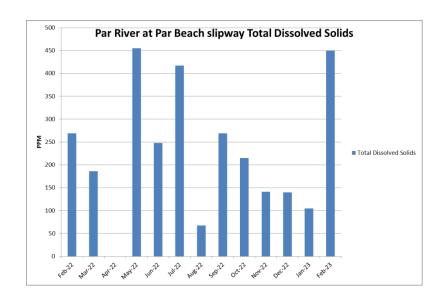
4. Par Beach slipway (SX 0776 53261)

On $\mathbf{1}^{\text{st}}$ March 2023 Brian Harrisson took another reading, which was 305 ppm.

- (b) We do not know if the bacteria levels are genuinely high risk and unsafe because the Aquagenx testing is for recreational waters in the USA.
- (c) Very high levels of Total Dissolved Solids at Par Beach slipway have been recorded before but are unusual. Over time, recording has taken place at all states of the tide. There seems no obvious explanation.

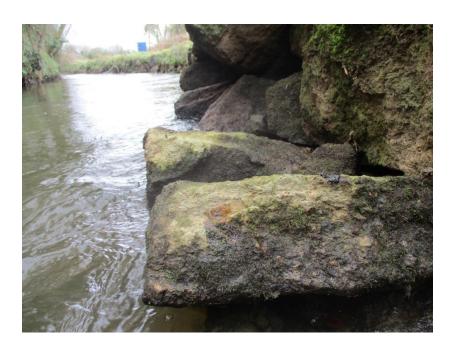
(a) Spraint: 1 old, 1 recent, all containing bones and scales on stone Luxulyan allotments – boulder in river (SX 04747 58056).

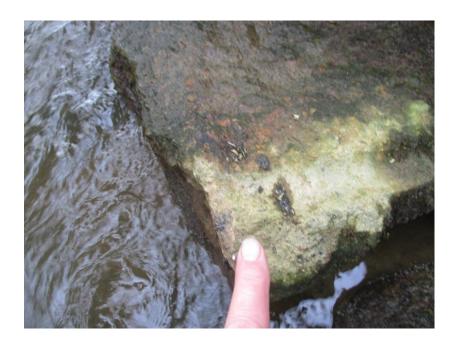
(b) Spraint: 1 old, 1 recent, all containing bones and scales on stone Luxulyan allotments – boulder in river (SX 04747 58056).

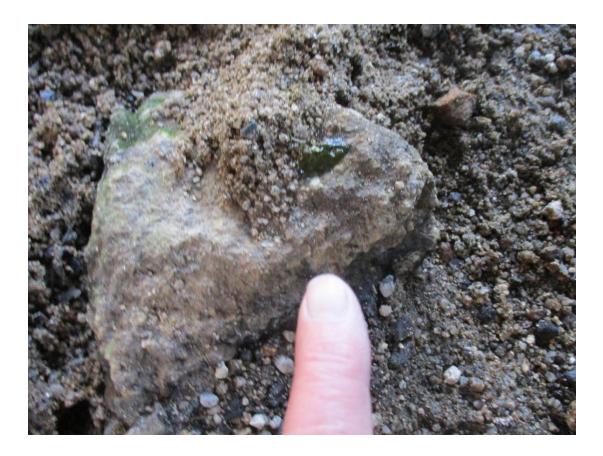
(c) Possible anal jelly under the canal bridge at Ponts Mill (SX 07312 56164).

There was clear evidence of the presence of otters between the allotments in Luxulyan and Prideaux Woods china clay works (disused) south of Ponts Mill. Evidence on the small beach beneath the canal bridge at Ponts Mill strongly suggested the presence of otters. No spraint was found but a similar smelling jelly, which may be anal jelly. The surface was highly disturbed but possibly there were paw prints.

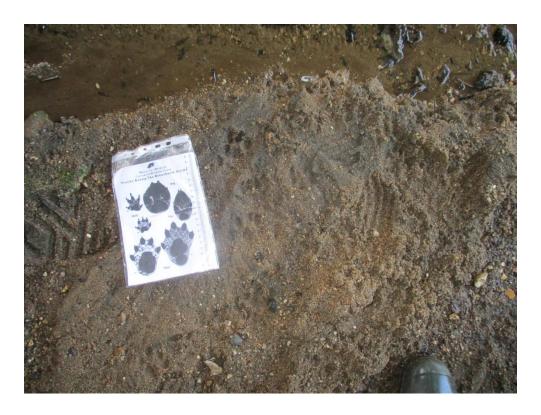
(d) Possible footprints under the canal bridge at Ponts Mill (SX 07312 56164). The ground was disturbed with at least one boot print (not mine). Animal prints were unclear, with one possible dog paw print.

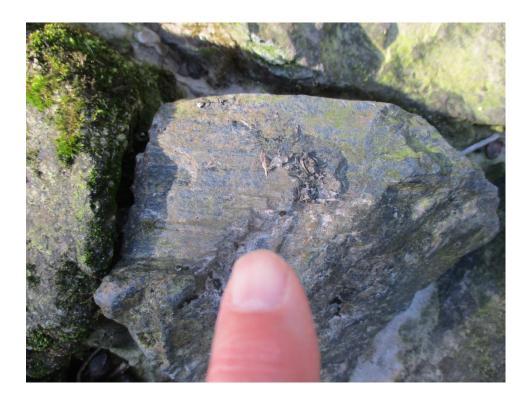
(e) Old spraint on bankside stone downstream from sluice gate at Ponts Mill (SX 07342 55795).

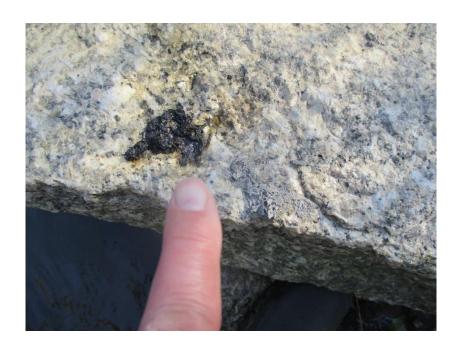
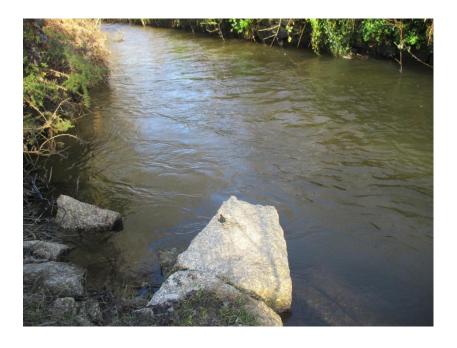
(f-g) Stone in river near path south of disused Prideaux Wood china clay works (SX 0722 5542).
