WESTCOUNTRY RIVERS TRUST CITIZEN SCIENCE

MONITORING OF THE PAR RIVER AND ITS TRIBUTARIES

DECEMBER 2022

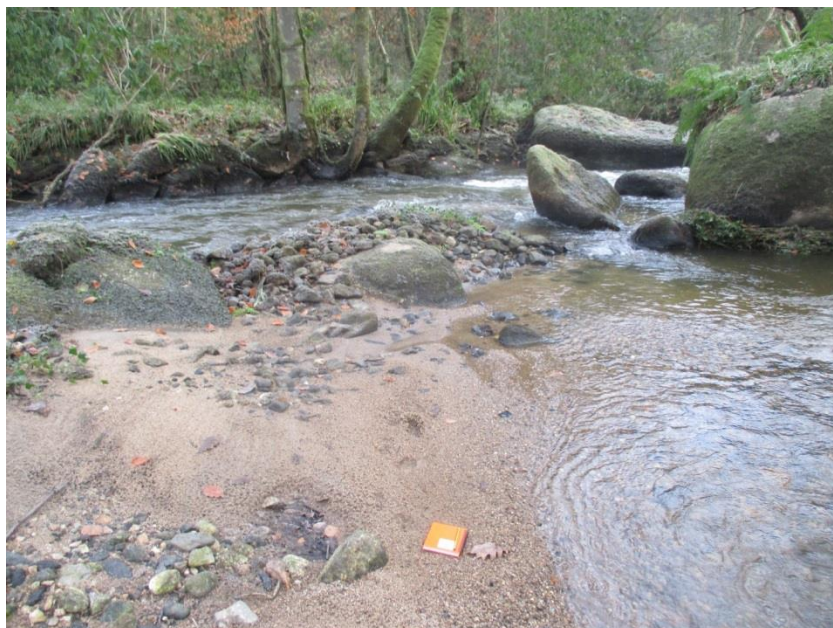
(a) Islet near Rock Mill Quarry (SX 05802 56860 on sand on island near Rock Mill quarry)

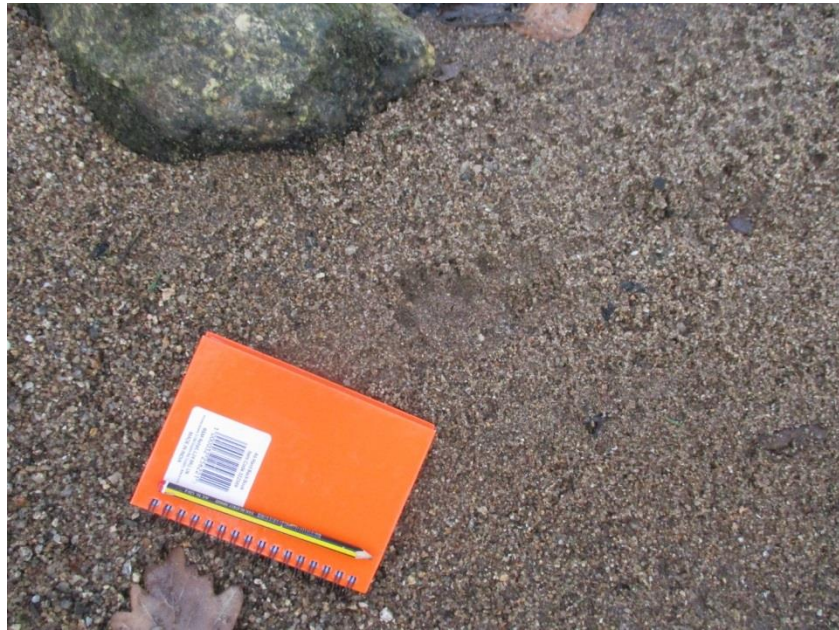
(b) Possible prints on islet but not clear enough to record on ORKS

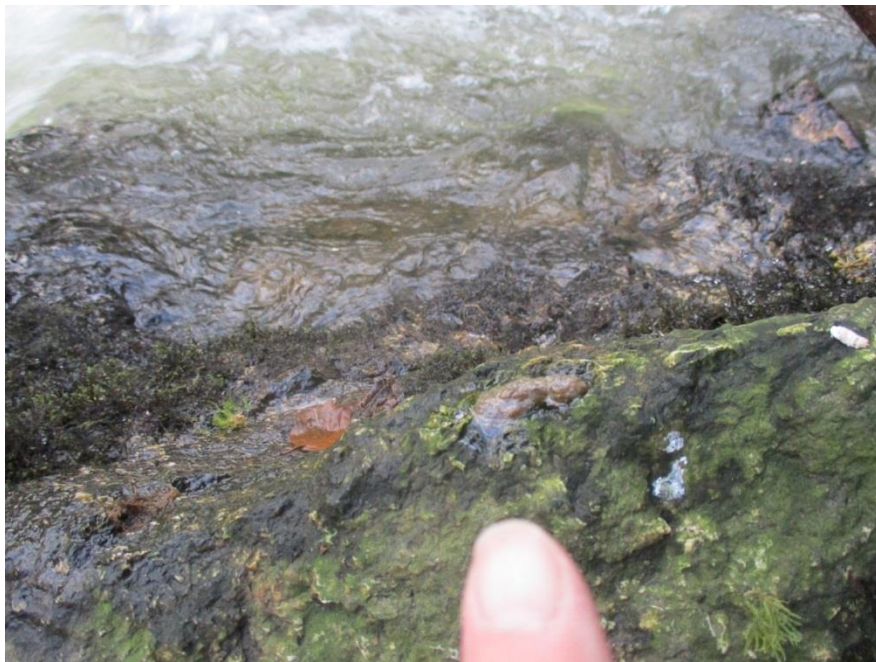
(c) Spraint near Lower Tramway (SX 0692 2564) jelly-like, no bones or scales visible

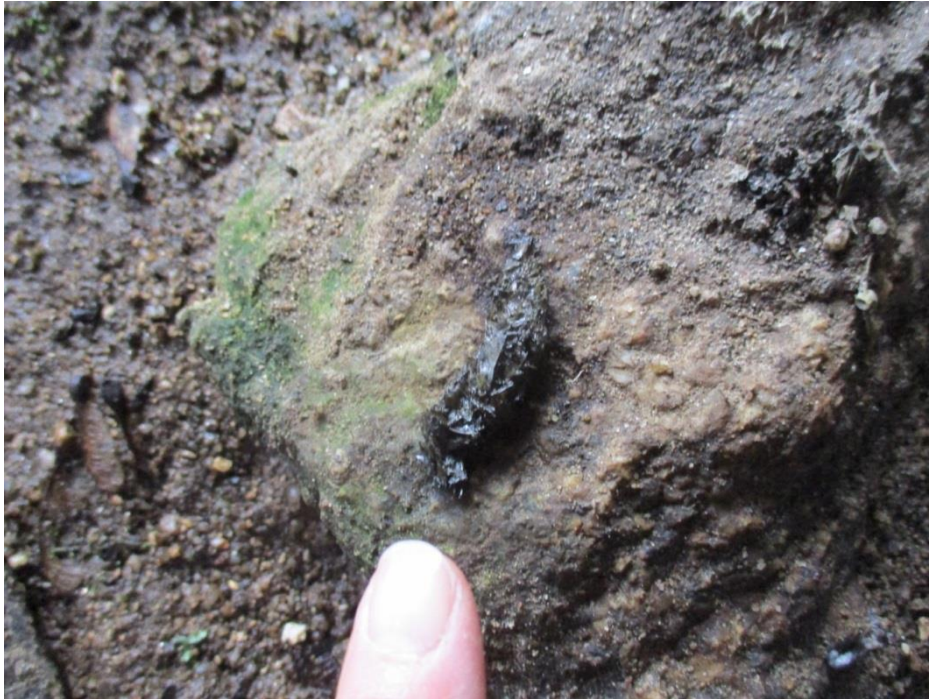
(d) Spraint under canal bridge at Pontois Mill (SX 07312 56164)

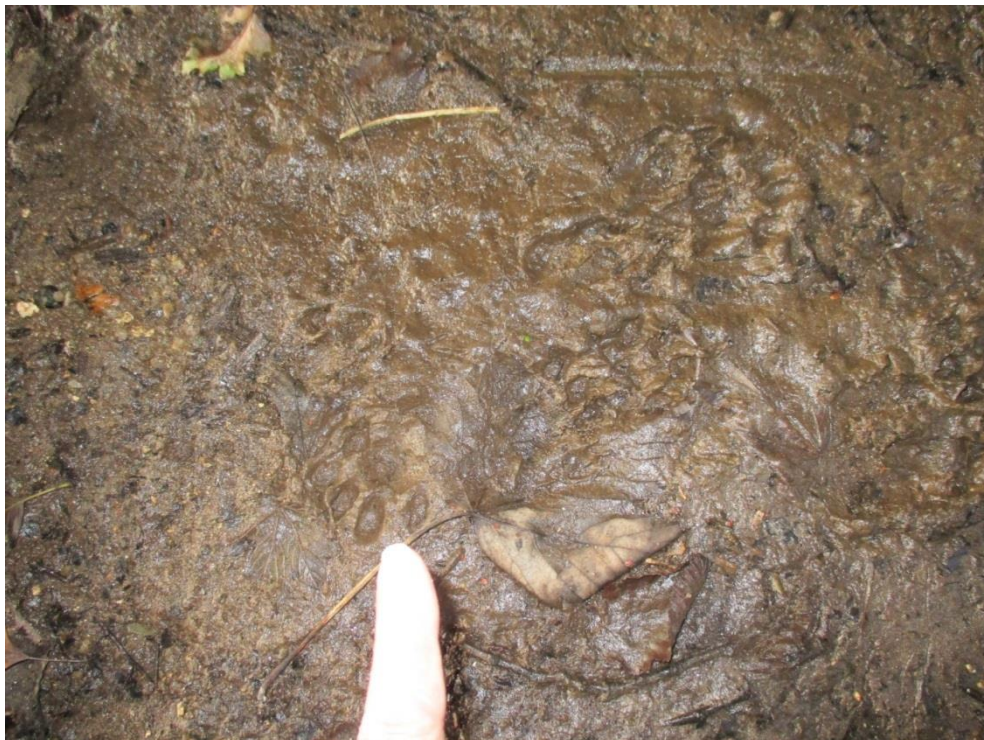
(e) Possible prints under canal bridge at Pontois Mill (SX 07312 56164)

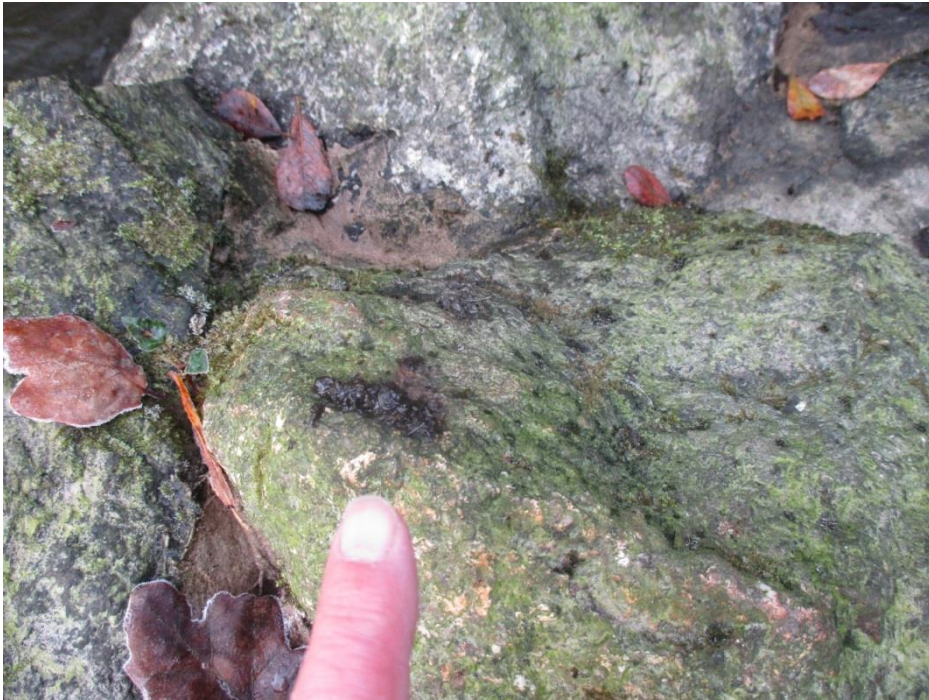
(f) Recent spraint near sluice gate downstream from Ponto Mill (SX 07342 55795)

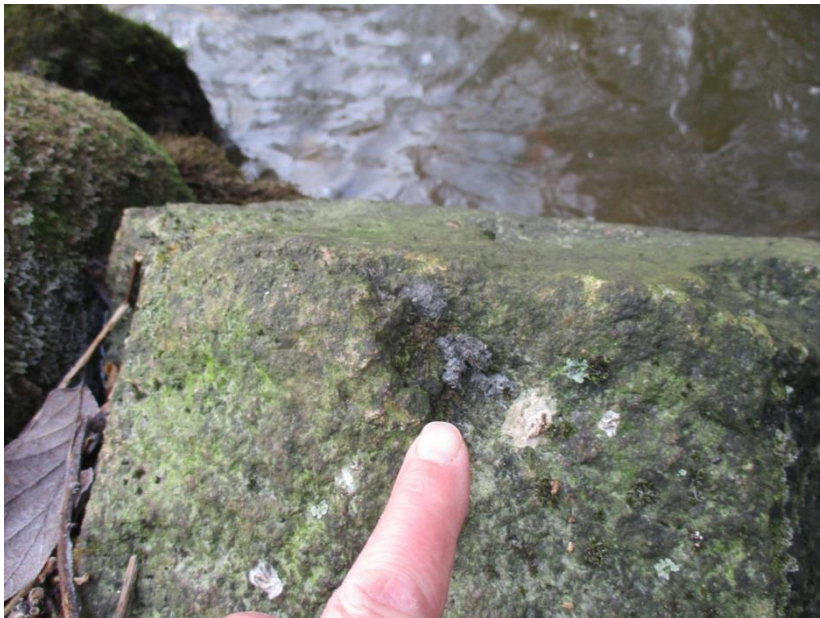
(g) Old spraint near sluice gate downstream from Ponto Mill (SX 07342 55795)

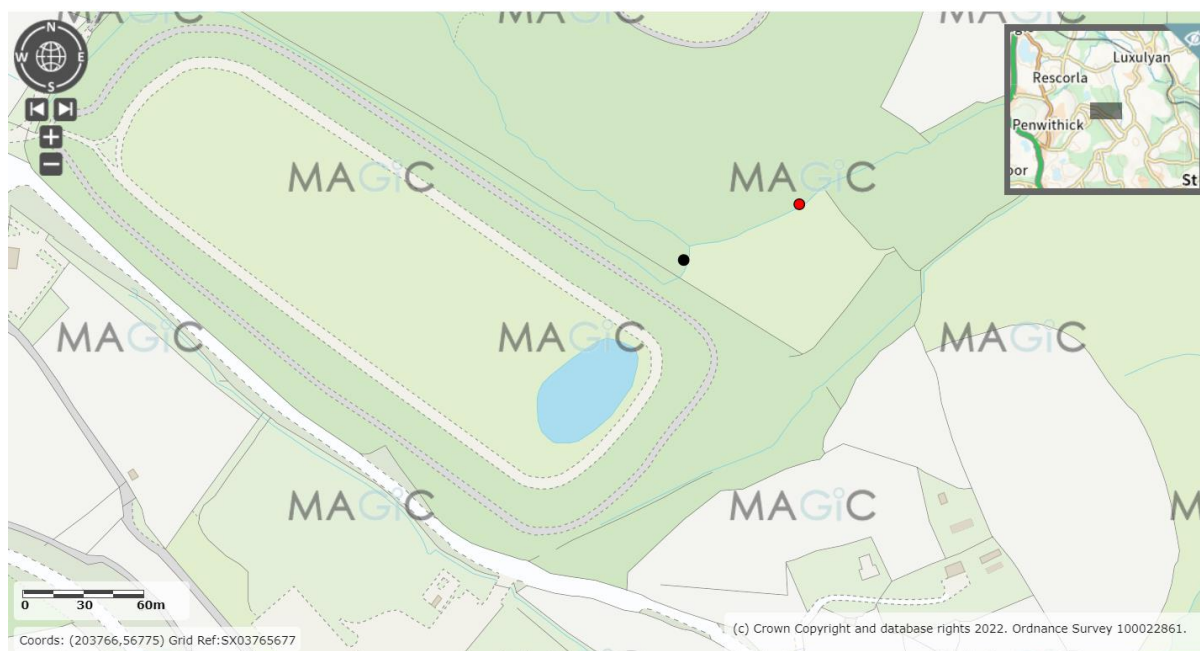
Monitoring was conducted on the Treverbyn/Treskillling Stream upstream and downstream of the confluence with the Innis Stream, which is ochre-stained as a result of flowing through former tin-streaming ground.

Site 1 Black dot SX 04058 56650: Treverbyn/Treskilling Stream upstream from confluence with Innis Stream.

Site 2 Red dot SX 04113 56670: Treverbyn/Treskilling Stream downstream from confluence with Innis Stream.

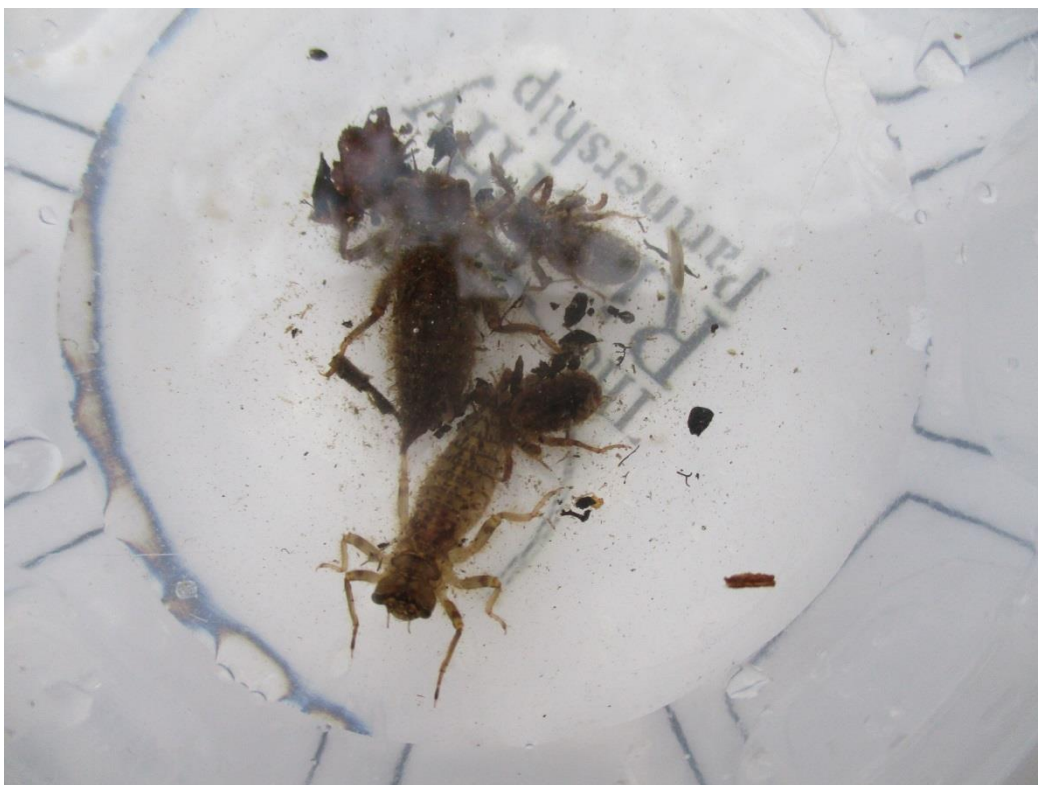
Other creatures were found, including several Golden-Ringed Dragonfly nymphs, a crane-fly larva and a caterpillar like creature. A frog was also seen near the stream.

Golden-Ringed Dragonfly nymphs

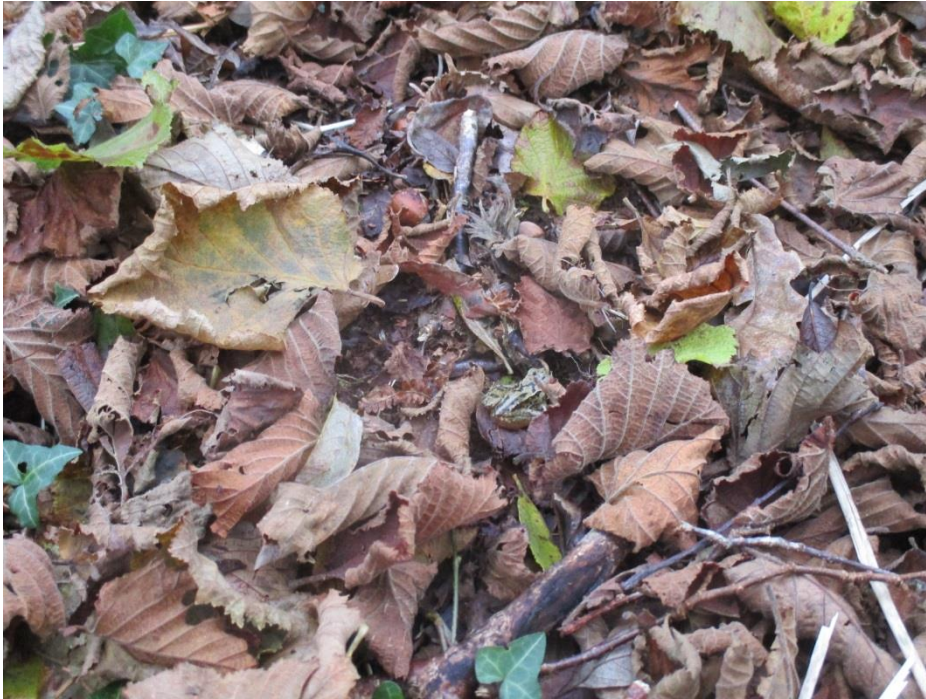
Frog

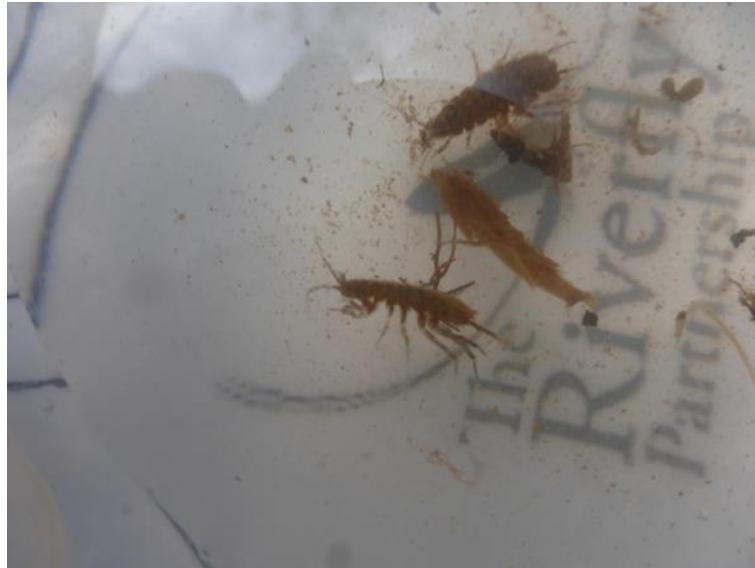
Site 2 produced creatures that we could not identify. Nick Taylor of Three Bays Wildlife group has identified them: *'The things that look like woodlice are hoglice. The species is almost certainly Asellus aquaticus, although it's hard to say for sure from the photos. The other thing isn't clear, although it could be a True Mayfly larva. Both types of creature generally live in silty/muddy conditions.'*

Hoglice

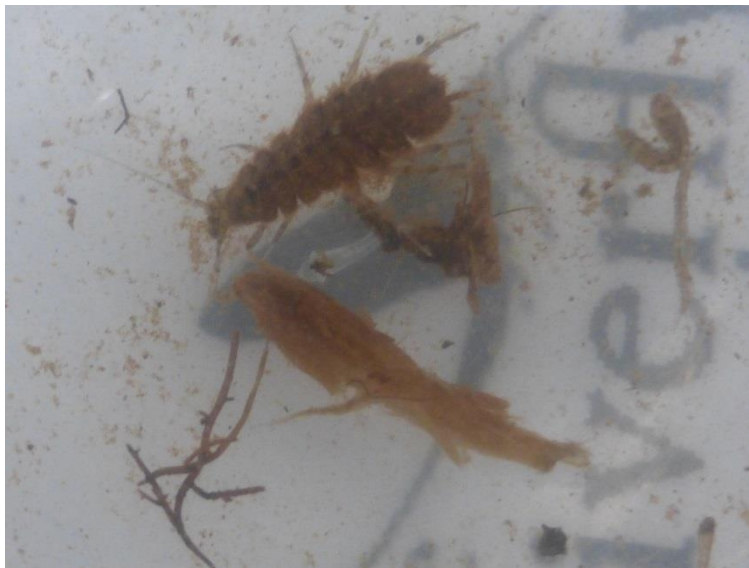
Hoglice
