MONITORING OF THE PAR RIVER AND ITS TRIBUTARIES

The monitoring group operates under the citizen science scheme run by the Westcountry Rivers Trust. Comments and opinions in this report are those of the authors only.

MARCH 2024

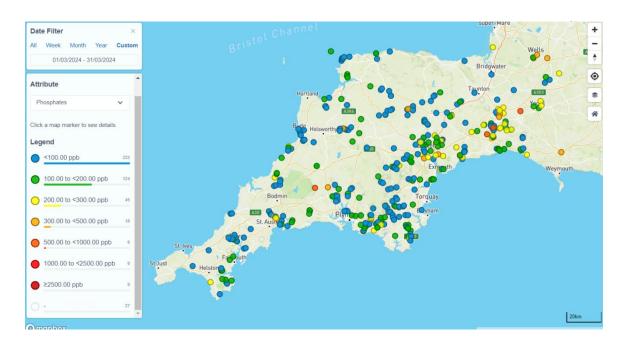
2. **Geographical comparison.** Source: Cartographer

PAR RIVER/TRIBUTARY	LOCATION	Phosphates PPB
Par	Criggan Moors, SX 01882 61133	0
Par	South of Minorca Lane, Par River, SX 02657 59788	0
Tributary	Carbis Stream SX 02834 59401	0
Par	Lavrean, Par River SX 03134 59164 NEW SITE	0
Par	Luxulyan allotments, Par River, SX 04732 58045	<mark>200</mark>
Par	Cam Bridges, Par River, SX 05292 57454	<mark>300</mark>
Tributary	Gatty's Bridge, Bokiddick Stream SX 05531 57953	0
Par	Treffry Viaduct, Par River, SX 05650 57179	<mark>200</mark>
Par	Lady Rashleigh Mine, Par River, SX 06451 56509	<mark>300</mark>
Tributary	Treesmill, Tywardreath Stream, SX 08873 55385	0
Par	Par Beach slipway, SX 0776 53261	0
Tributary	Polmear Stream, Ship Inn, SX 08749 53417	100

Results in red show phosphate levels that are High (WRT advice).

- (a) Even with the very high river level, which has a diluting effect, phosphate readings were High downstream from St Austell North STW at Luxulyan.
- (b) Quite possibly the wet weather and subsequent high river levels may have led to STW using CSOs (Combined Sewer Overflows) to discharge into waterways but we have not made any observations this month to suggest the presence of sewage, other than the mention of a smell at Cam Bridges. Two online sources do provide information about spills:

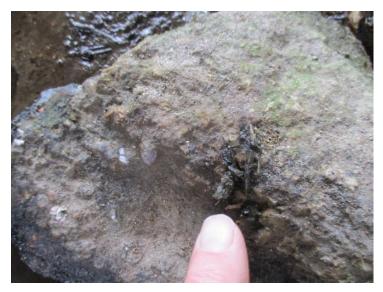
Old spraint with fish bones and scales below Ponts Mill canal bridge. Probably recorded before.
