## WESTCOUNTRY RIVERS TRUST CITIZEN SCIENCE MONITORING OF THE PAR RIVER AND ITS TRIBUTARIES

# AUGUST 2022

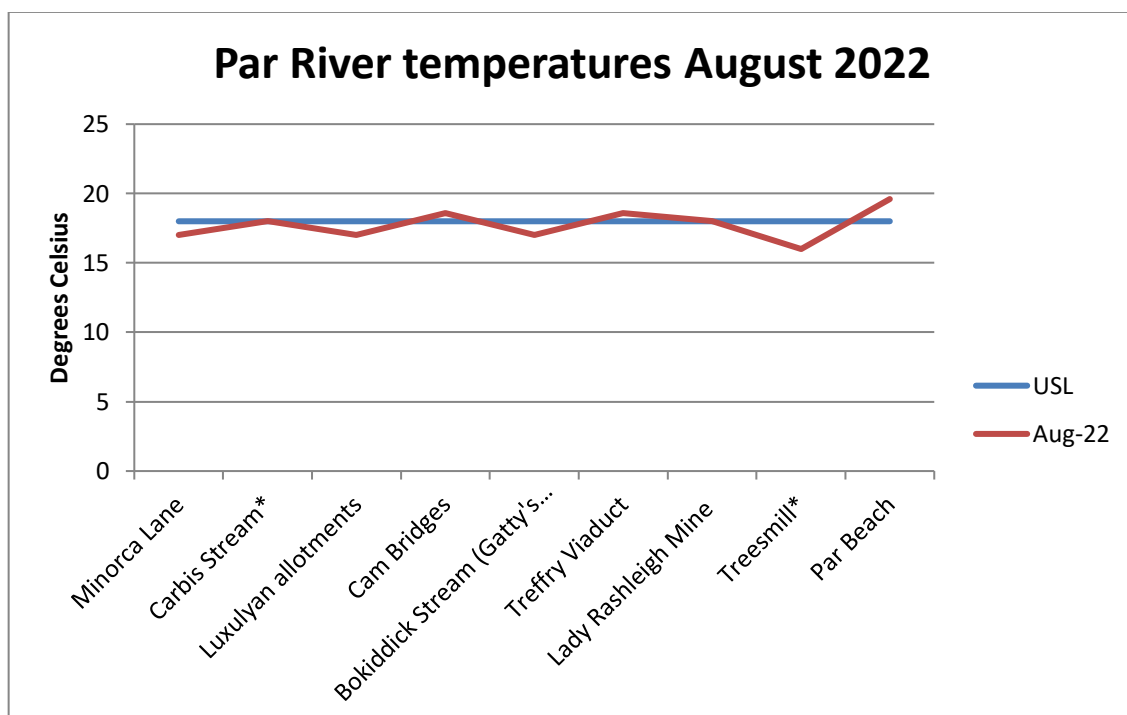
### 4. Graph August 2022

**USL – Upper Safe Limit** Our assumption is that 18° Celsius is the upper safe limit for fish. This simplification is a useful rule of thumb.

(a) Water temperatures were high, reflecting the heatwave and drought, which are widely thought to have been caused by climate change. At 5 of the 9 CSI sites shown in the preceding tables and graphs, the temperature was 18° Celsius or higher (it was 16° on the river at Criggan Moor). This is a critical temperature for the health of fish since they struggle to cope in anything warmer. It should be noted that readings were taken at different times of the day which might affect readings.

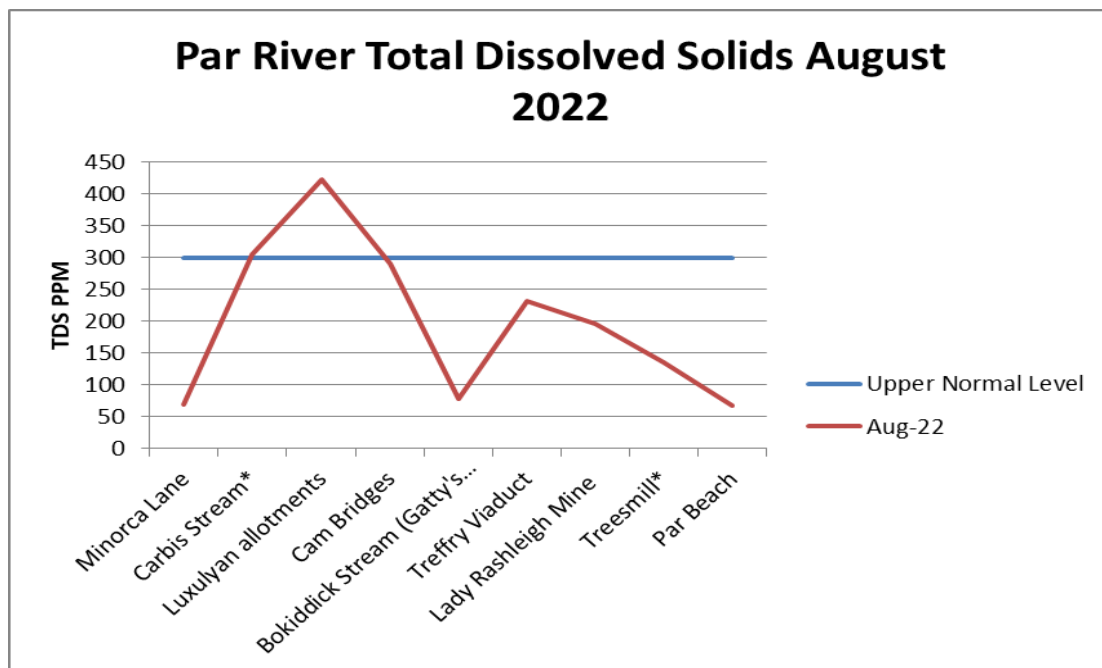
The WRT advice is: 'TDS levels vary between catchments due to natural geology etc. We generally say that after 6 months of sampling you should have an idea of what is 'normal' for your river. Looking at the scorecards for the Lower Par for 2020 and 2021 I would say that anything above 300 ppm is too high.'

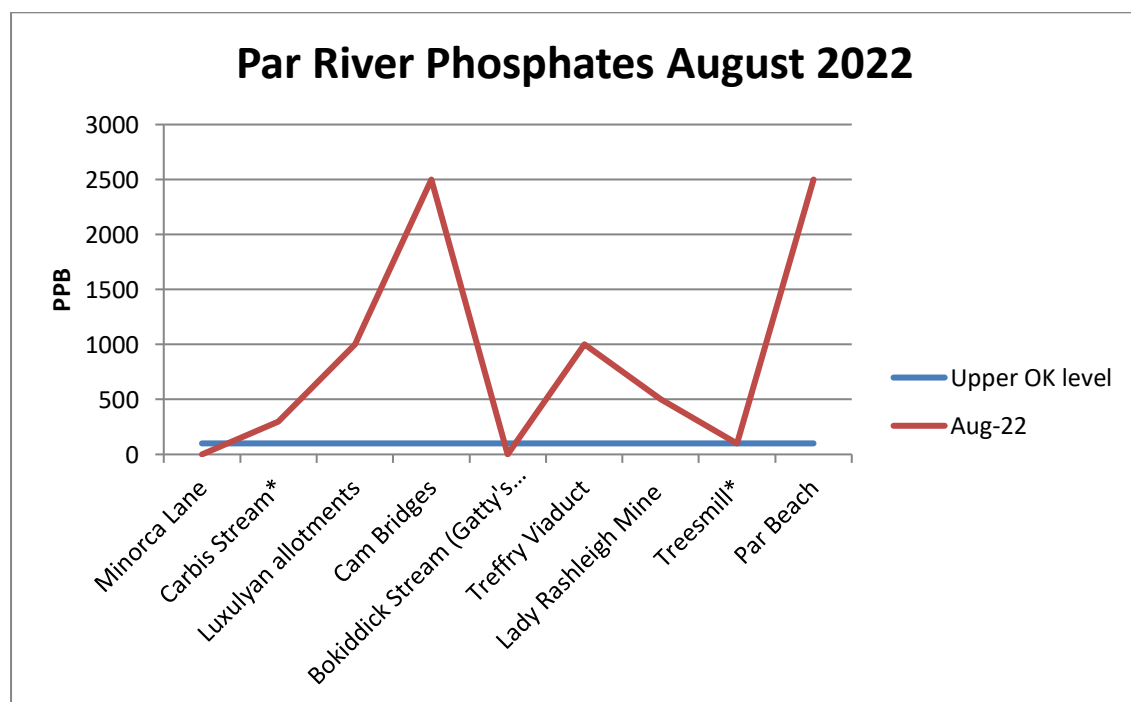
\*indicates a tributary of the Par River. USL is 100 Parts Per Billion which, according to WRT, is the Upper Safe Level.

(b) Phosphate levels in the main river from Luxulyan allotments downstream to the sea were Too High or High, as well as being High on the Carbis Stream. At Cam Bridges and Par Beach slipway the maximum reading of 2500 parts per billion were noted.

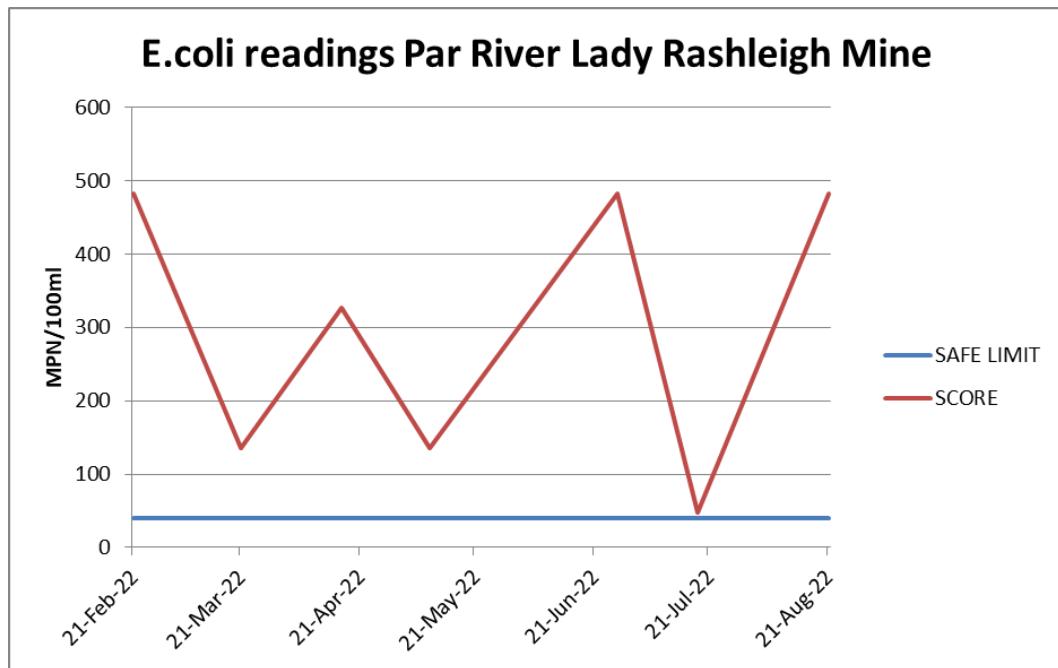
E.coli readings Lady Rashleigh Mine SX 06451 56509

The USA Health risk Category for Recreational water deems all 3 sites Very High Risk/ Unsafe for e coli and Very Unsafe for Total Coliforms. Although the river is not deemed a recreational bathing area, Lady Rashleigh mine is used recreationally by families visiting the Luxulyan Valley, and the water flows into the sea at Par Sands.

(c) Bacteria levels are unhealthy according the Aquagenx test, which is based on US standards for recreational and surface waters. Samples were taken from 2 sites upstream of St Austell North STW (Criggan Moor and Minorca Lane) as well as the usual site at Lady Rashleigh Mine. This was to test the possibility that the STW was the cause of higher bacteria levels, a theory that our group has become doubtful about. This doubt was confirmed because at all three sites the readings were identical: Very High Risk/Unsafe for E.coli and Very Unsafe for Total Coliform according to the United States Environmental Protection Agency Recreational Water Health Risk Category Based on Minimum Probable Number and Upper 95% Confidence Level.
