WESTCOUNTRY RIVERS TRUST CITIZEN SCIENCE

MONITORING OF THE PAR RIVER AND ITS TRIBUTARIES

JANUARY 2022

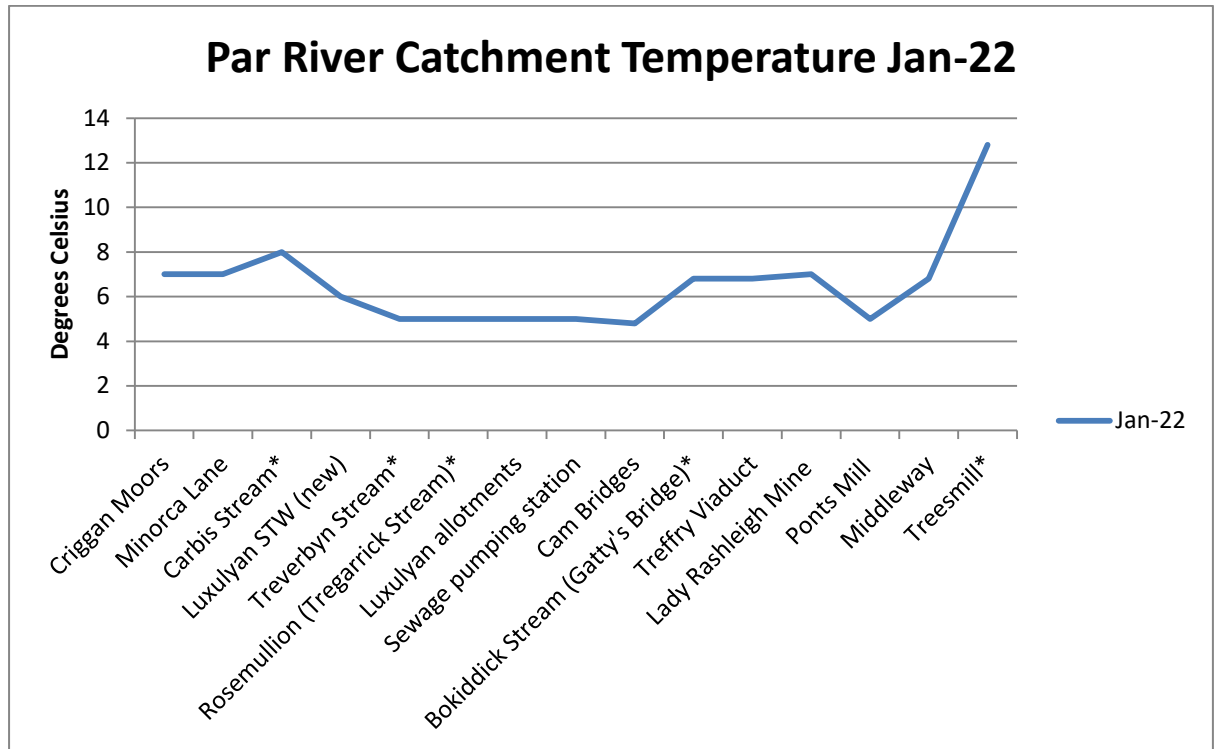
The Tywardreath Marsh Stream at Treesmill has had the highest temperature in 3 of the 5 months selected in the above graph. Middleway has had the highest temperature in the other months, including January 2022. This may be worth watching.

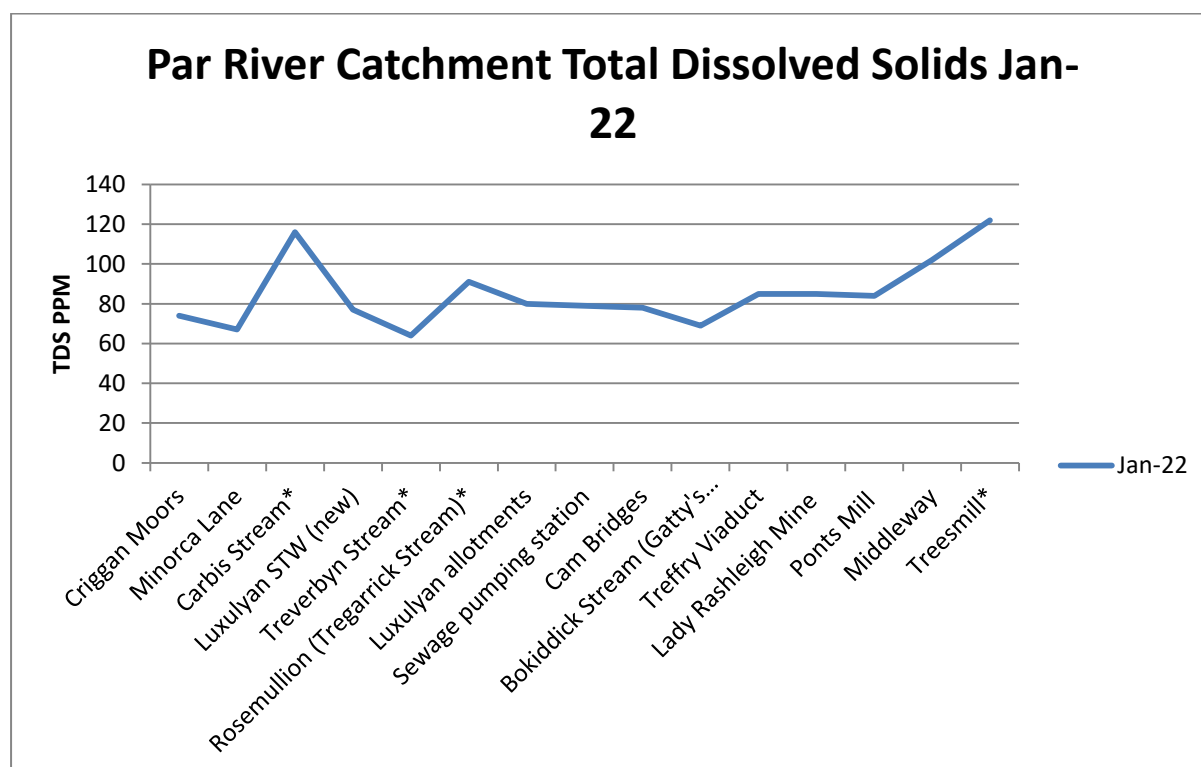
This month Middleway recorded the highest TDS, followed by the Carbis Stream and Treesmill. The Carbis Stream and the Tregarrick Stream at Rosemullion often show relatively high TDS scores. In the former case this is believed to be the result of china clay and in the latter it is believed to be silt that has accumulated as a result of slurry being sprayed on adjacent fields. It isn't known why Middleway and Treesmill should have had such a relatively high score in January 2022.

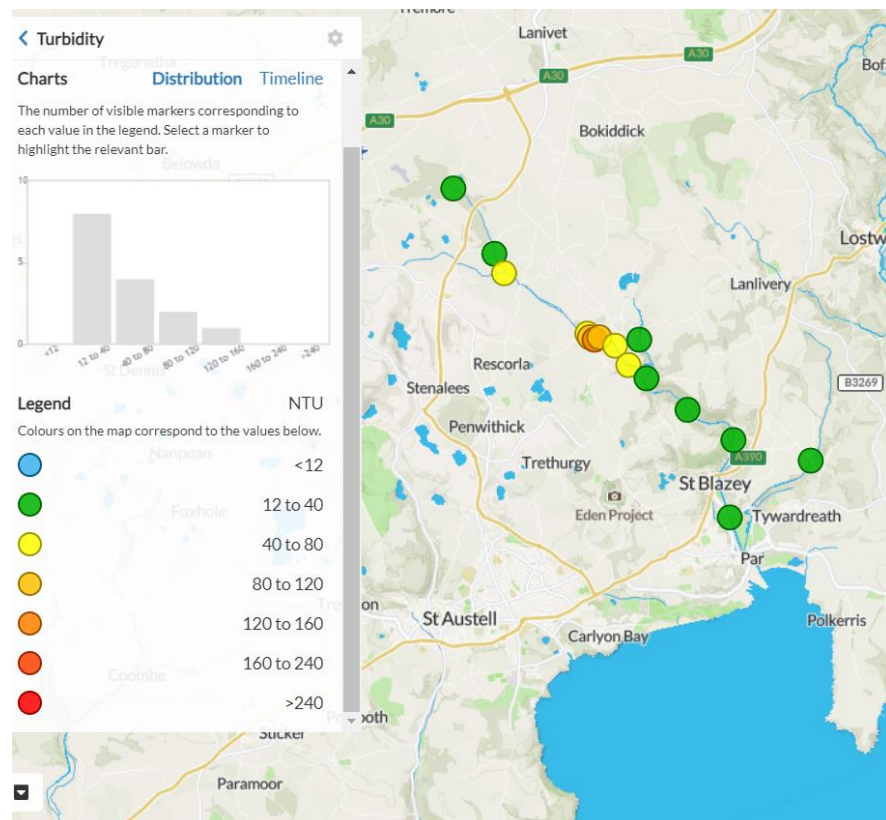
As the table shows, the high turbidity scores were recorded on 8th January when the river was high and fast-flowing as a result of heavy rain. This might not account for all the higher turbidity scores recorded during the time our group has been active.

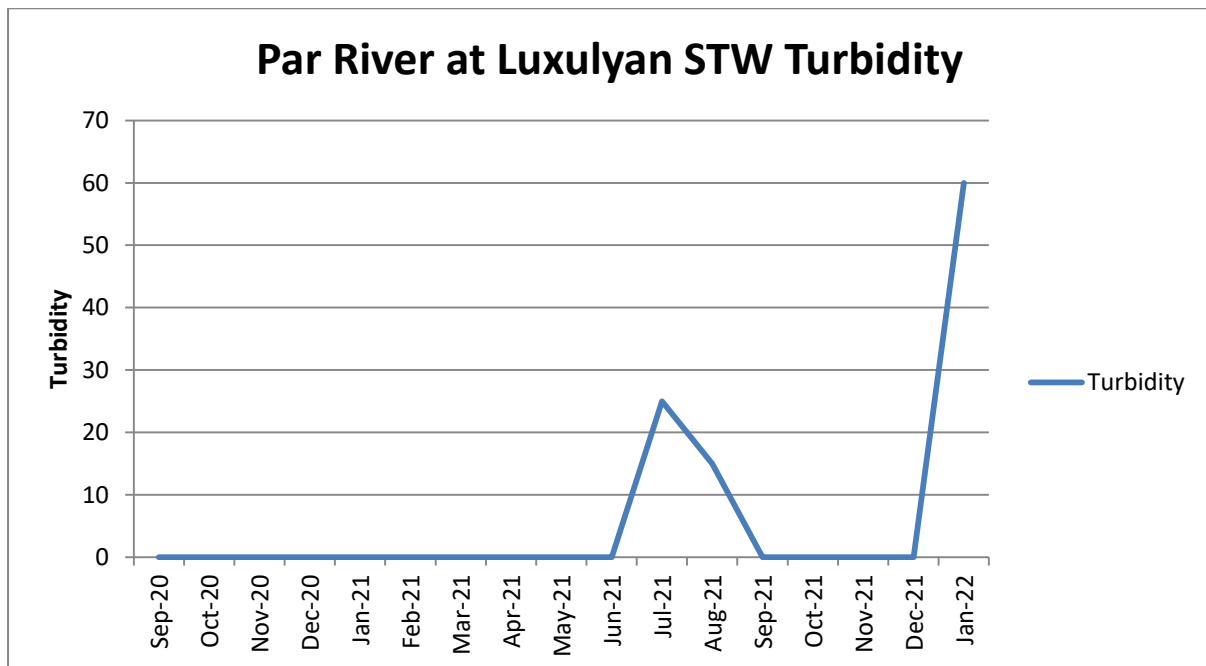
(a) Luxulyan sewage treatment works is usually measured from November 2021 at SX 04472 58114 (formerly at SX 0455 58114) but on this occasion the sample was taken at SX 0455 58114.

High turbidity at three of the four selected sites appears to be linked to recent heavy rainfall. At the STW, pumping station and Cam Bridges this round of monitoring followed heavy rainfall, as had been the case in July and August. Monitoring at downstream sites, such as Lady Rashleigh Mine, one day later allowed time for levels to return to normal levels.

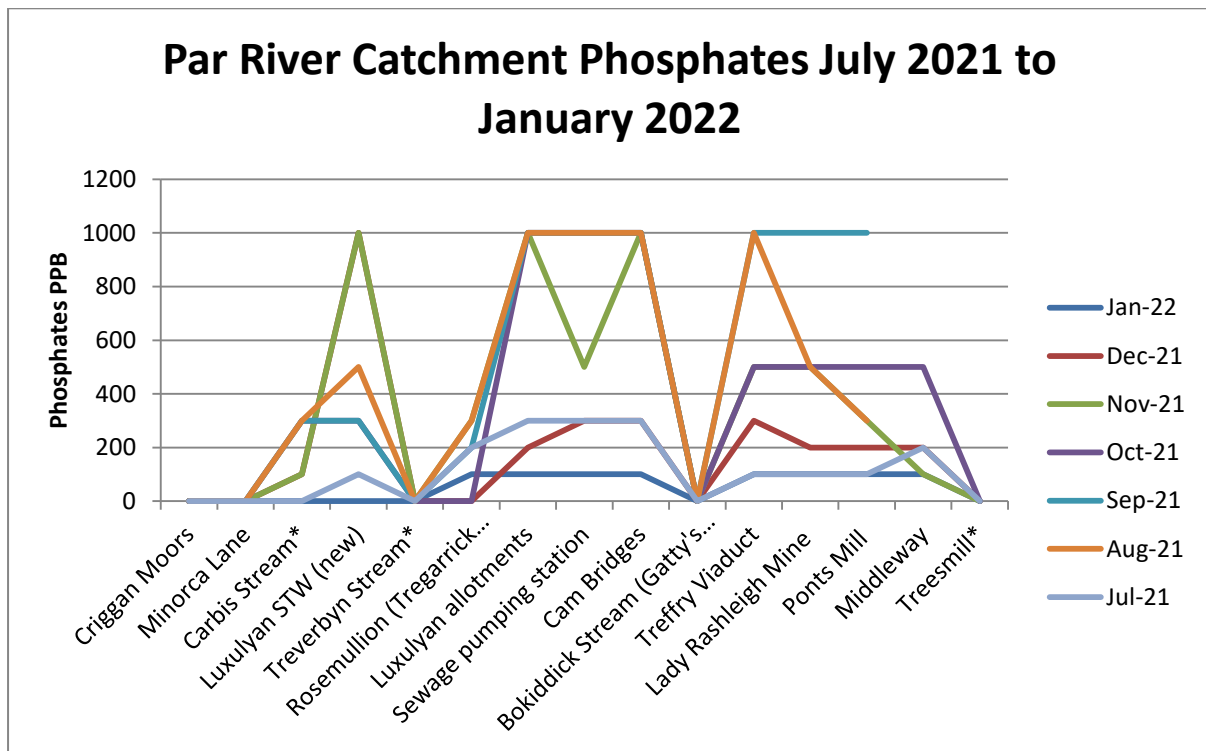
N.B. Readings of 2500 PPB have been recorded on dates preceding those shown in this graph.

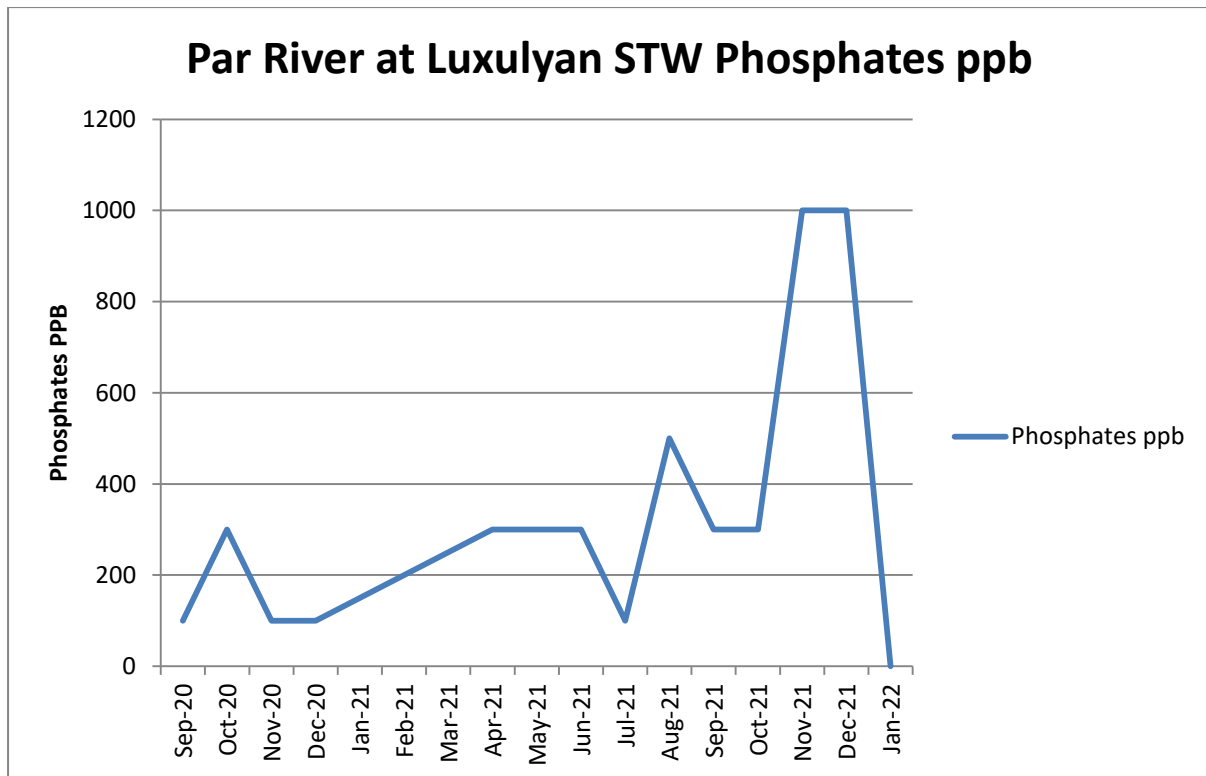
- (a) Luxulyan sewage treatment works is usually measured from November 2021 at SX 04472 58114 (formerly at SX 0455 58114) but on this occasion the sample was taken at SX 0455 58114. Measurements at the old monitoring spot, before November 2021, can be diluted by the proximity of 2 small outfalls (believed to be land drains).

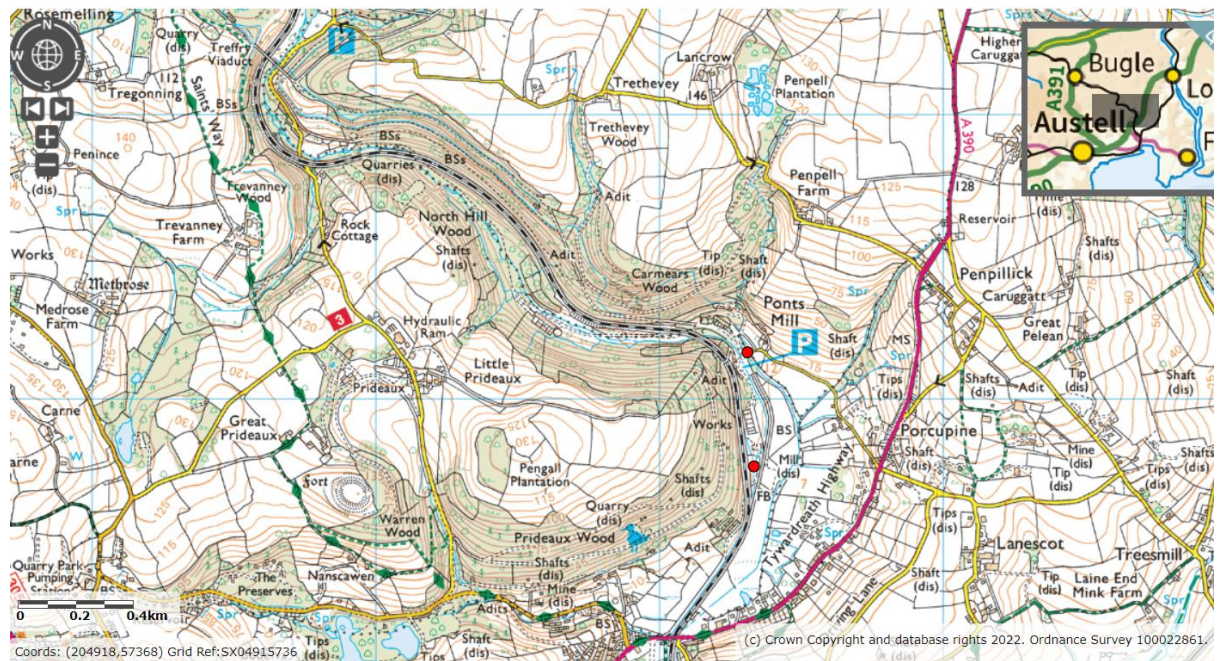
EVIDENCE	SEEN/ ORKS*	LOCATION	NOTES
Spraint - fresh	✓*	SX 0733 5577 On fallen tree trunk east bank of river about 100 metres downstream from Pontois Mill sluice gates and upstream of footbridge	Very large spraint.
Spraint – recent	✓*	SX 07312 56164 under canal bridge at Pontois Mill	Fish bones in spraint.
Spraint - old			
Anal jelly			
Sign heap			
Staining			
Tracks			
Path			
Slide			
Holt			
Hover			
Couch			
Live sighting			
Corpse
