## WESTCOUNTRY RIVERS TRUST CITIZEN SCIENCE

# MONITORING OF THE PAR RIVER AND ITS TRIBUTARIES

## JUNE 2022

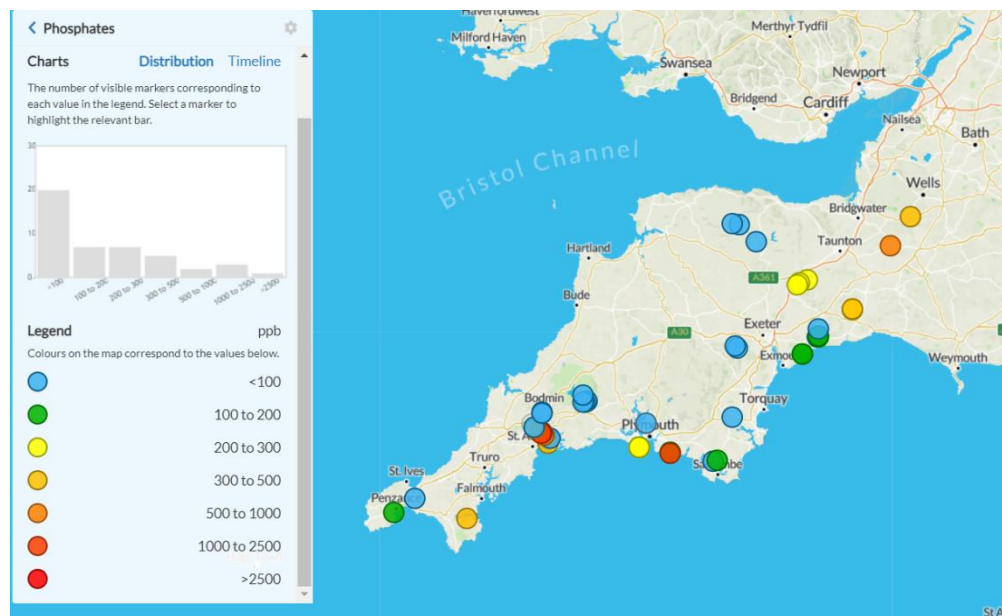
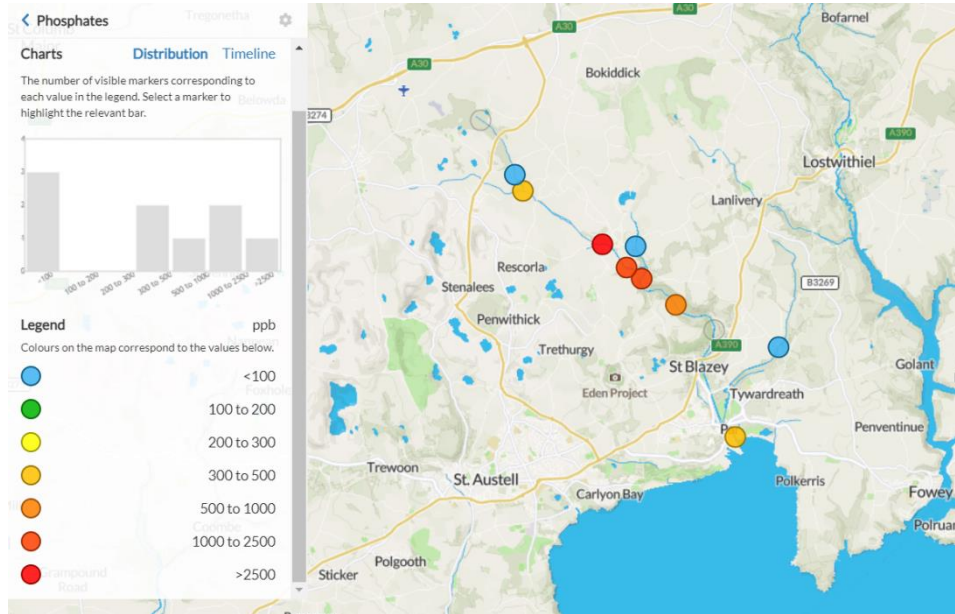
**Par River Phosphate levels**

Phosphate levels were relatively low for the second month running. Levels at all sites monitored were OK according to the WRT guidance. Maximum scores of 2500 PPB have been recorded at some sites but these precede the date range in the historical graphs. They have been recorded on Cartographer.

(b) Phosphates remain alarmingly high. Although low river levels may be relevant, it does not excuse the situation. WRT classifies any reading below 100 Parts per Billion as OK; therefore anything above that is not. A score of 300 PPB on the Carbis Stream was High according to WRT guidelines. This may be connected to china clay pollution, although the water was clear this time. It seems that Imerys has permission to discharge into this stream. However, the really excessive levels of Phosphates were noted first at Luxulyan allotments. Indeed the score of 2500 PPB was the maximum that our testing kit could register. In the past, a score of 2500 at Luxulyan allotments has prompted us to contact the Environment Agency hotline. At the monitoring sites downstream the scores were: 1000, 1000, 500 and 300 PPB – either High or Too High. The graph for average scores since July 2021 on page 17 demonstrates that the Lower Par River (from Luxulyan downstream) has a serious problem with Phosphate pollution. Previous investigations from the Environment Agency lead us to believe that the source is the St Austell North Sewage Treatment Works at Luxulyan. We need an independent enquiry into the source of this pollutant and the impact on the health of the river. If the SWW plant is having a negative impact on the river this ought to be made public and moves undertaken to get a resolution.

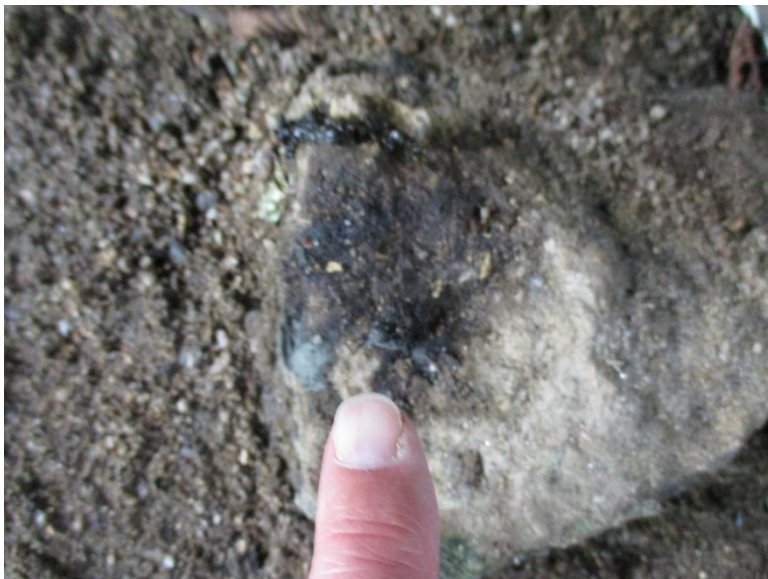
1. Recent spraint under canal bridge at Ponto Mill (SX 07312 56164). Possible tracks were seen but these lacked definition.

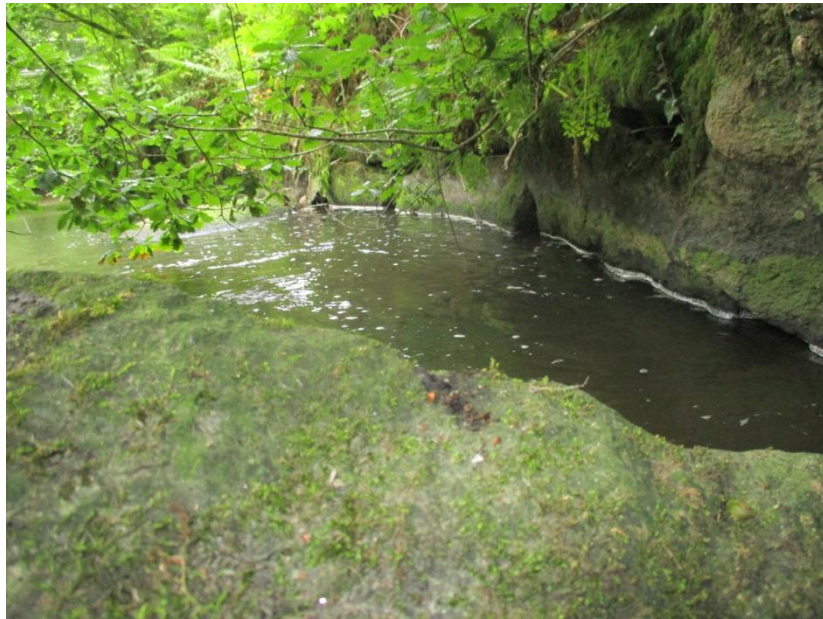
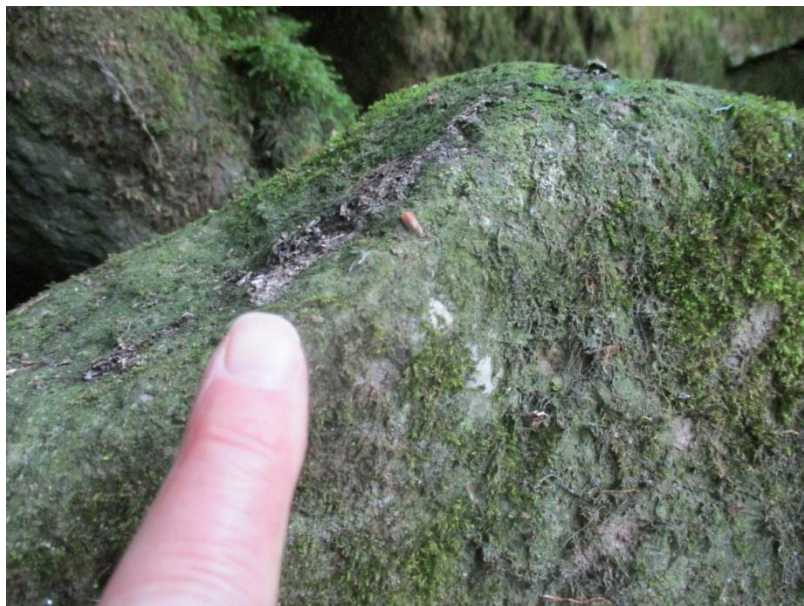
2. Old spraint on the boulder at Lady Rashleigh Mine (SX 06456 56498). It is thought to have been deposited since the last survey in May.

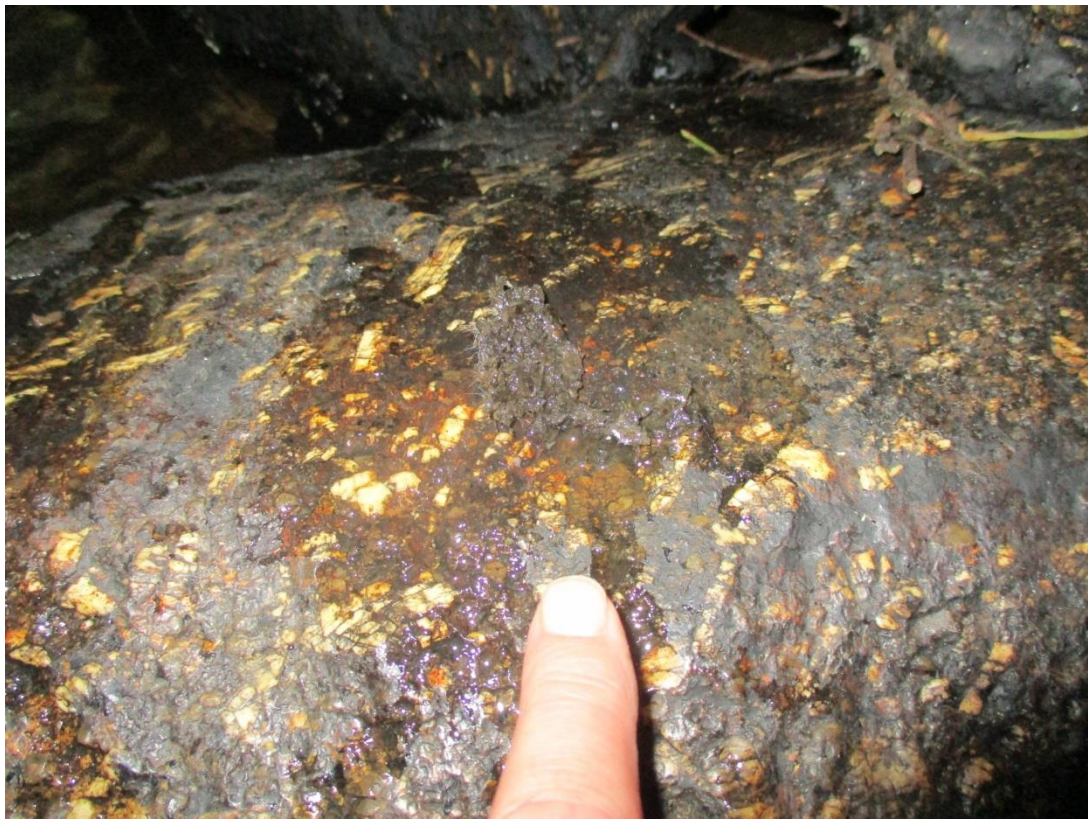
3. A boulder under the road bridge at Rock Mill (SX 05725689) was exposed because of the low water level. This has often had spraint in the past. On this occasion there were two deposits: one

smelt and looked like otter spraint (second photo); the other had no clear smell and seemed to have bits of fur or hair (first photo).

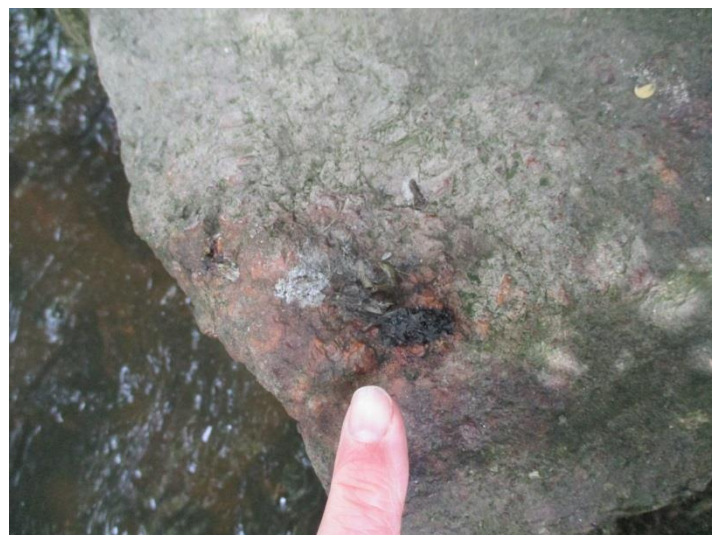
4. Recent spraint at Luxulyan allotments (SX 04747 58056).

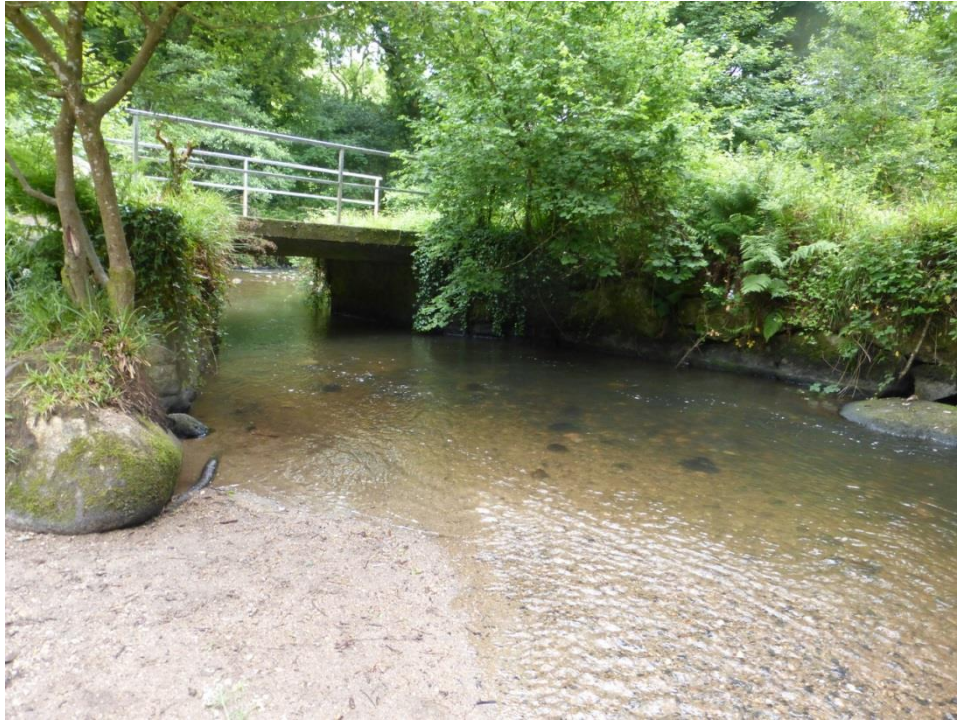
**The Par River at Lady Rashleigh Mine**

The testing kit comes from the USA and the judgements reflect US standards: it is not known what, if any, standards are applied to British rivers. E.coli readings for June would be classified as *Very High Risk/Unsafe*. The Coliform score is judged *Very Unsafe*. That said, we are not aware of any person or animal being adversely affected by the water in the river here or at other locations, so it would be wrong to be alarmist.

We have a suspicion, based only one set of readings in a previous month, that St Austell North STW is a source (there were also concerns about the situation near Minorca Lane). However, this is an inadequate basis on which to make a judgement. Our group has been told that some water treatment works use ultra-violet treatment to kill bacteria. But this uses a lot of energy, so with commercial pressures there may be an incentive not to use it.
