# MONITORING OF THE PAR RIVER AND ITS TRIBUTARIES

The monitoring group operates under the citizen science scheme run by the Westcountry Rivers Trust. Comments and opinions in this report are those of the authors only

## OCTOBER 2023.

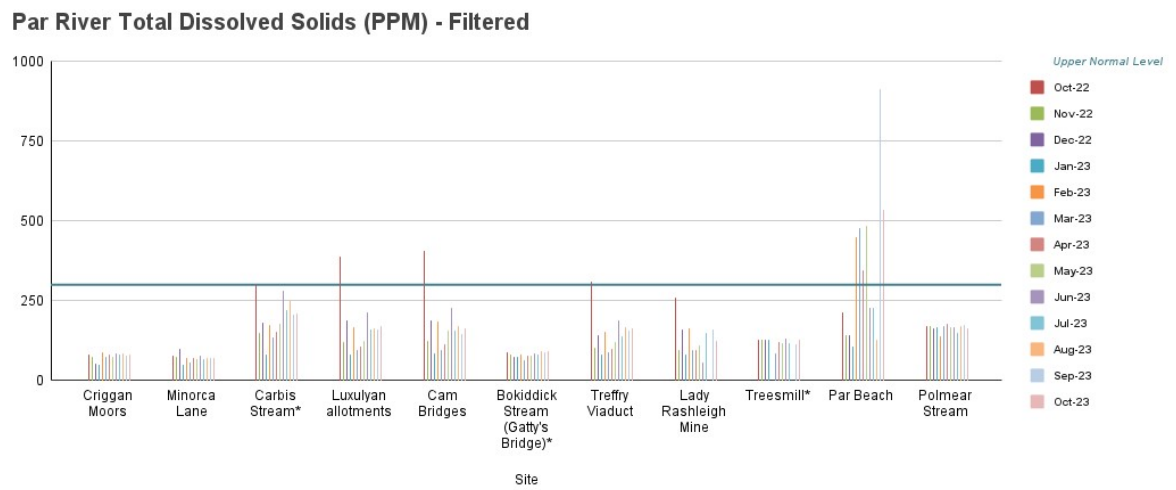
**(b) From 1<sup>st</sup> October 2022 to now**

- (a) Phosphate levels remain unacceptably high.
- (b) The Total Dissolved Solids reading at Par Beach was, once again, above the guidance of 300 parts per million.
- (c) Hardly any wildlife was noted.
- (d) The smell at Cam Bridges has been reported by various people as coming from sewage. This evidence is anecdotal but some of the observers do have relevant knowledge. It has probably been under-reported in our monitoring at that spot. The smell is not noticeable closer to the STW at Luxulyan allotments, so it is assumed that the turbulence caused by the weir is releasing the smell. Nonetheless, it is concerning that the presence of sewage can be detected.
- (e) More foam was noted on the 18<sup>th</sup> October than usual. Besides the familiar line of bubbles, assumed to come from the treated effluent outfall at St Austell North STW, larger quantities were seen (see photo on page 1).

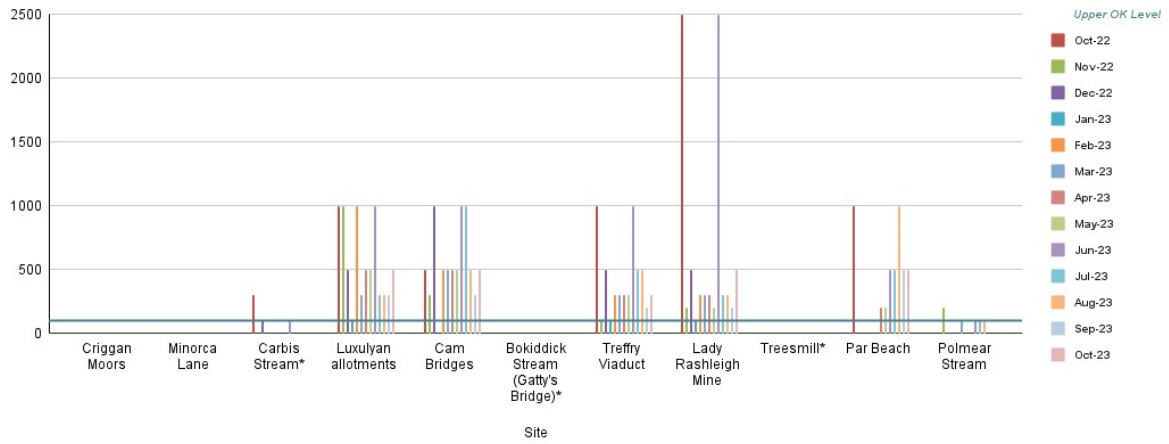
**Par River Phosphates (PPB) - Filtered**

Results in red show phosphate levels that are Too High (WRT advice).
