WESTCOUNTRY RIVERS TRUST CITIZEN SCIENCE

MONITORING OF THE PAR RIVER AND ITS TRIBUTARIES

FEBRUARY 2023

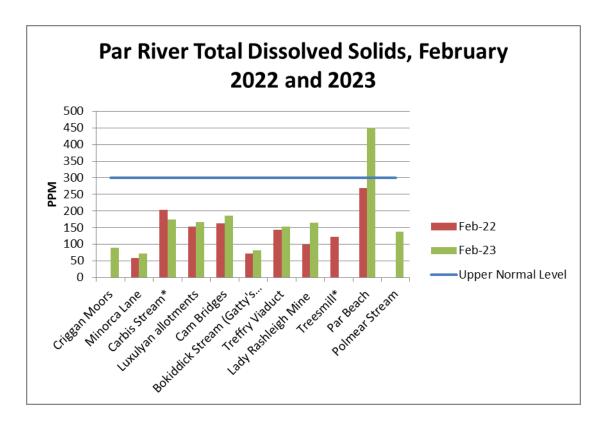
The WRT advice is: 'TDS levels vary between catchments due to natural geology etc. We generally say that after 6 months of sampling you should have an idea of what is 'normal' for your river. Looking at the scorecards for the Lower Par for 2020 and 2021 I would say that anything above 300 ppm is too high.'

4. Par Beach slipway (SX 0776 53261)

On $\mathbf{1}^{\text{st}}$ March 2023 Brian Harrisson took another reading, which was 305 ppm.

- (b) We do not know if the bacteria levels are genuinely high risk and unsafe because the Aquagenx testing is for recreational waters in the USA.
- (c) Very high levels of Total Dissolved Solids at Par Beach slipway have been recorded before but are unusual. Over time, recording has taken place at all states of the tide. There seems no obvious explanation.

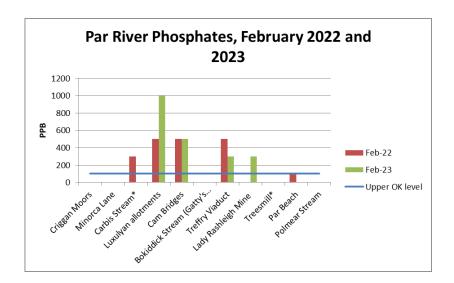
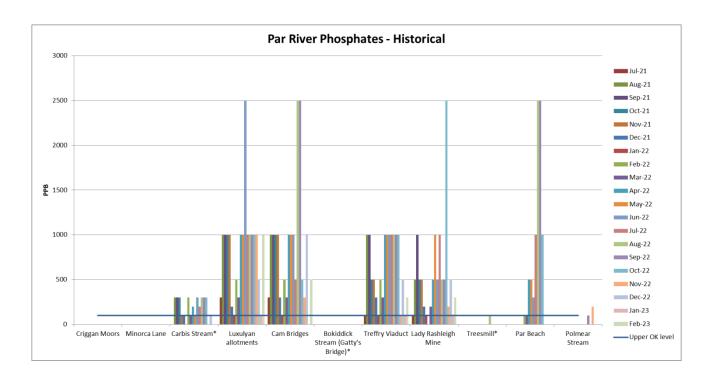
5. Historical data on phosphates:

- (a) Levels of E.coli and Total Coliforms at Lady Rashleigh Mine were still in the range classed as 'High Risk. Prob. Unsafe' according to the Aquagenx testing methodology.
- (b) Phosphate levels have returned to being High or Too High (WRT classifications) between Luxulyan allotments and Lady Rashleigh Mine after the diluting effects of high river levels in January.

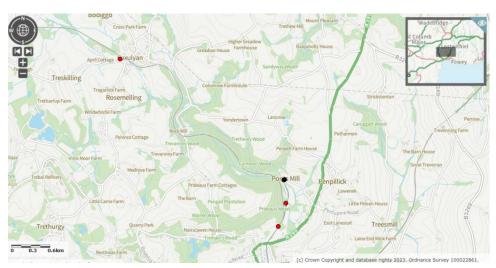
(a) Spraint: 1 old, 1 recent, all containing bones and scales on stone Luxulyan allotments – boulder in river (SX 04747 58056).

There was clear evidence of the presence of otters between the allotments in Luxulyan and Prideaux Woods china clay works (disused) south of Ponts Mill. Evidence on the small beach beneath the canal bridge at Ponts Mill strongly suggested the presence of otters. No spraint was found but a similar smelling jelly, which may be anal jelly. The surface was highly disturbed but possibly there were paw prints.
